ELECTRICAL SAFETY FOLLOW UP INSPECTION REPORT (3RD)

Factory Name	ASWAD COMPOSITE MILLS LTD. (U-2)			Note:	
Address	Kabirpur, Ashulia, Savar				
FACTORY ID	11095	ELECTRICAL SAFETY INSPECTION DATES			Other Factory:
Initial Inspection Date		05/08/2014			
Report Received Date		04/21/2015			
Date of 1st Follow Up		11/17/2015		Date of 5th Follow Up	
Date of 2nd Follow Up		07/17/2016		Date of 6th Follow Up	
Date of 3rd Follow Up		03/05/2017			
Date of 4th Follow Up					
Inspected by	Banna Kasemi

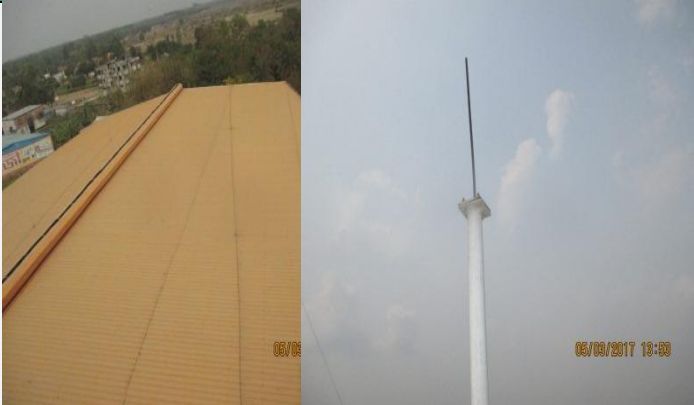
Item No	Accord Inspection Observation	Accord Action Plan (Recommendation)	Accord Time line (given in report)	Comments from Accord (After Physical Inspection)	Final Timeline (Approved timeline)	Final Action Plan (Factory)	Progress Status (On the date of inspection)	Pictorial Evidence
33	New Finding: Lightning Protections System (LPS) is inadequate for the factory	Redesign/modify LPS for your factory to increase safety	8/30/2016 12:00:00 AM	On 05/03/2017: Corrected.	11/08/2016	Done. Already installaed three airterminal.	Corrected
