**FIRE SAFETY FOLLOW UP INSPECTION**

<b>Factory Name</b>	ASWAD COMPOSITE MILLS LTD. ( U-2)		<b>Accord ID</b>	11095
<b>Address</b>	Kabirpur, Ashulia, Savar			
<b>Inspection Date</b>	05/08/2014		<b>Report Received Date</b>	21/April/15
<b>Date of 1st Follow-up</b>	17/November/15	<b>Date of 2nd Follow-up</b>	17/July/16	
<b>Date of 3rd Follow-up</b>	05/March/17	<b>Date of 4th Follow-up</b>		
<b>Date of 5th Follow-up</b>		<b>Date of 6th Follow-up</b>		
<b>Date of 7th Follow-up</b>		<b>Date of 8th Follow-up</b>		
<b>Date of 9th Follow-up</b>		<b>Date of 10th Follow-up</b>		
<b>Inspected by</b>	Nasif Javed Tofa

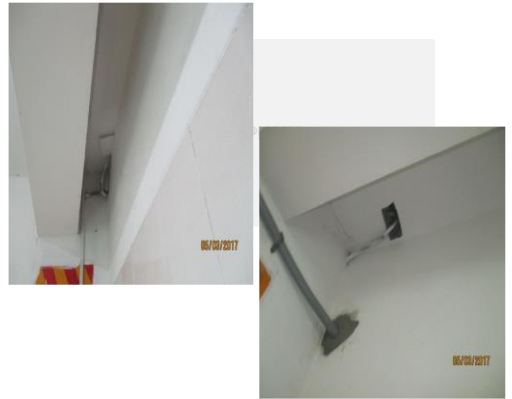
Item No	Accord Observation	Accord Recommendation	Timeline given by Accord	Comments after Physical Inspection	Supposed to complete(DD /MM/YYYY)	Final Action Plan (Factory)	Status on the date of Inspection	Pictorial Evidence
1	Exterior walls of Main Building-1 close to (less than 5 ft from) Ancillary Building-1 are penetrated for installing electrical cables from 3rd floor to ground floor. The penetrations are not sealed or protected. Moreover, non-rated openings are available on those exterior walls.	Provide fire-resistive rated opening and penetration protection for rated walls and assemblies in accordance with Alliance Standard Sections 4.6 and 4.7. Consult a qualified fire protection engineer to design the required opening protectives and penetration systems.	12/12/2014	On 17/11/16: In Progress. Factory has provided fire-resistive rated construction for side wall but non rated opening. Final CAP Timeline: Expired. Committed Timeline: Within 30th November 2015. On 17/07/16: Corrected. All unprotected open has been closed with proper fire rated wall. On 05/03/2017: Corrected. No unseal penetrations were observed during the time of inspection.	30/11/2015	Completed	Corrected

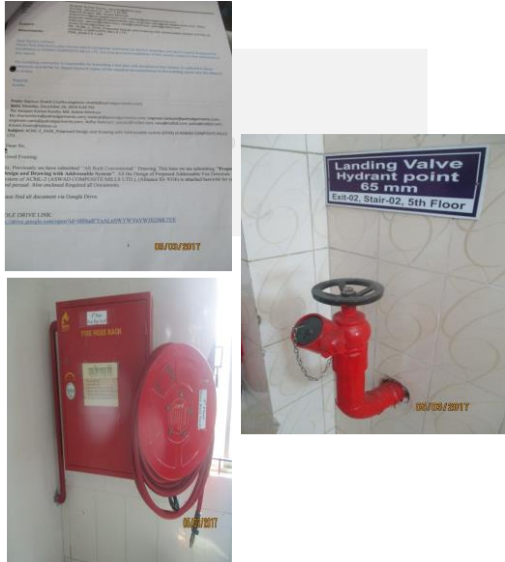
Item No	Accord Observation	Accord Recommendation	Timeline given by Accord	Comments after Physical Inspection	Supposed to complete(DD /MM/YYYY)	Final Action Plan (Factory)	Status on the date of Inspection	Pictorial Evidence
2	The height of the highest occupied floor of Main Building-1 is 16.46 m (54.00 ft), which is more than 10 m (33 ft) above grade, so a Class-III standpipe system is required for the building. There is no standpipe system in the building that meets the requirement of NFPA 14, 20, 22 and 25. Only a class II standpipe system is available in all buildings. 40 mm fabric hoses (UL Standard) are connected to an underground water reservoir. On the roof, hose pressure was found to be sufficient. Hose size, pressure, and water capacity are sufficient.	Install a standpipe system at required locations designed by a qualified fire protection engineer. The system is to be compliant with the requirements of NFPA 14. The hydraulic calculations should be reviewed by Alliance and review to be completed prior to start of work. All standpipe system installations shall be submitted for review by the Alliance for review prior to commencement of installation according to 5.4.3.2.	19/12/2014	On 17/11/16: In Progress. Factory has been reviewed the fire fighting drawing by Alliance. Rectification work is in progressing. On the other hand the factory will finished the rectification work within committed timeline according to Alliance reviewed drawing. On 17/07/16: Partially corrected. Reviewed drawing from Alliance was available during 2nd follow-up inspection. Installation was almost completed. Fire pump controls shall be interfaced with FACP if applicable. All valves controlling connections to water supply shall be listed or approved as per NFPA 14, section 4.5.1 (Commissioning of the system in-front of contractor/ 3rd party will be done by Accord). On 05/03/2017: Design of standpipe system was reviewed by Alliance. Factory has shown the approval mail copy during the time of inspection. Installation work is in progress.	15/12/2015	Completed	In Progress

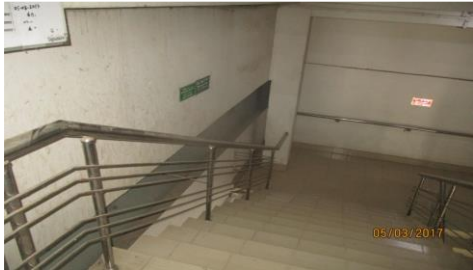
3	Main Building-2 is constructed with decking sheet over RCC Casting, which is not fire-rated.	Provide fire-resistive rated construction barriers between floors in accordance with Alliance Standard Section 4.5. Consult a qualified fire protection engineer to design the rated construction barriers.	16/01/2015	On 17/11/16: In Progress. Factory has provided fire-resistive rated construction for side wall but non rated opening. On 17/07/16: Corrected. No unprotected openings was found during 2nd follow up inspection. All openings has been closed with proper fire rated separation. On 05/03/2017: Corrected as per previous follow-up.	30/11/2015	Completed	Corrected

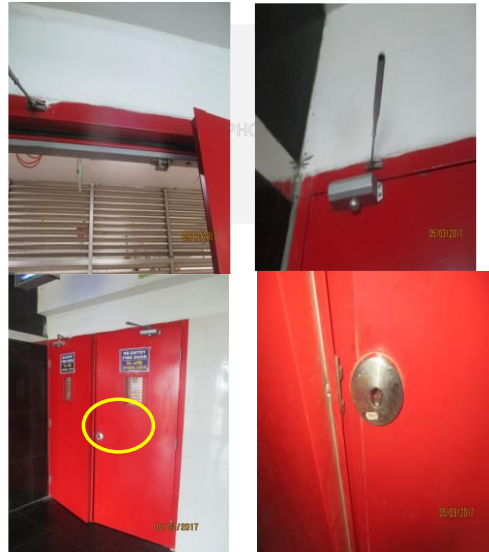
Item No	Accord Observation	Accord Recommendation	Timeline given by Accord	Comments after Physical Inspection	Supposed to complete(DD /MM/YYYY)	Final Action Plan (Factory)	Status on the date of Inspection	Pictorial Evidence
4	There are 3 staircases in Main Building-1. None of the staircases is fireproof. For two staircases, there are no certified fire doors on any floor. At south-east corner staircase, fire doors are installed on each floor having credible certificates. In the staircase of the Ancillary Building-1, there are unprotected openings towards Main Building-1. Exit enclosures of Main Building-2 are not fire protected.	Provide fire-resistive rated construction barriers and associated opening protection for exit enclosures in accordance with Alliance Standard Sections 4.5 and 4.6. Consult a qualified fire protection engineer to design the required rated construction barrier.	19/12/2014	On 17/11/16: In Progress. Factory has installed non listed fire rated door. On 17/07/16: No action has been taken yet for building 02. Fire door installation is going on in building 01. On 05/03/2017: Factory has installed fire doors at building-1 where doors were found physically damaged during the time of inspection. Door closer, coordinators, smoke seal etc. were missing for both building-1 and building-2. Fire door installation is still pending at building-2.	31/12/2015	Completed	In Progress

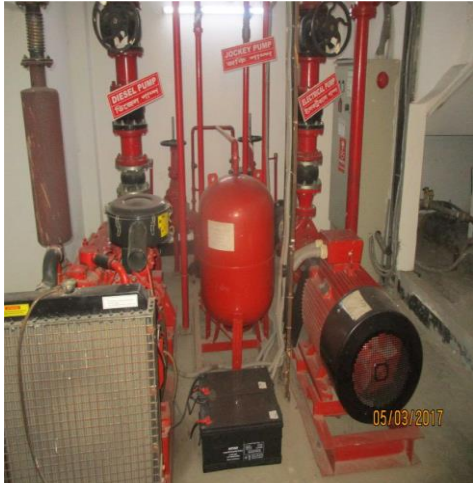
5	The pump available is dedicated for fire fighting. There is jockey pump and the pump is connected to alternative power source. However it does not comply with the requirements of Alliance Standards and NFPA 20. The capacity of the water reservoir is sufficient.	Install a pump dedicated for fire fighting or fire protection following the requirements of NFPA 20. Fire pump installation is to be tested for final acceptance in presence of Alliance and a final inspection of the installation shall be conducted by the Alliance prior to final acceptance. Acceptance testing of the installation shall be in accordance with NFPA 20, 22, and 24 testing requirements. Documentation of all testing shall be submitted to the Alliance for review prior to final acceptance. This pump is to be connected to alternative power source like generator and the generator is to be connected with ATS (auto starter).	22/11/2014	On 17/11/16: In Progress. Factory has separated the fire pump power connection. But they did not installed auto transfer switch (ATS). On 17/07/16: It is an integrated part of fire fighting system. On 05/03/2017: It is an integrated part of fire fighting system.	15/12/2015	Completed	In Progress

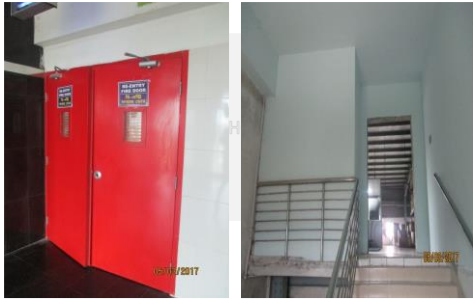
Item No	Accord Observation	Accord Recommendation	Timeline given by Accord	Comments after Physical Inspection	Supposed to complete(DD/MM/YYYY)	Final Action Plan (Factory)	Status on the date of Inspection	Pictorial Evidence
6	Door widths were sufficient in accordance with Alliance Standard in all buildings but do not have required ratings. Some exits are collapsible type. Some fire doors are fitted having credible certificates.	Replace non-compliant doors and frames in the means of egress with side-swinging doors. Replacement doors shall be a minimum width of 0.8 m (32 in), and are listed, approved, self-closing, fire rated door assemblies (door and frame) with latching panic hardware.	14/11/2014	On 17/11/16: In Progress. Factory has installed non listed fire rated door. On 17/07/16: No action has been taken yet for building 02. Fire door installation is going on in building 01. [N.T: Door width is sufficient but all the doors are not found listed and with required ratings.] On 05/03/2017: Fire door installation work is still in progress for building-02. Fire doors were found physically damaged at building-01. Door parts like door coordinators, door closers , smoke seal were missing.	31/12/2015	Completed	In Progress

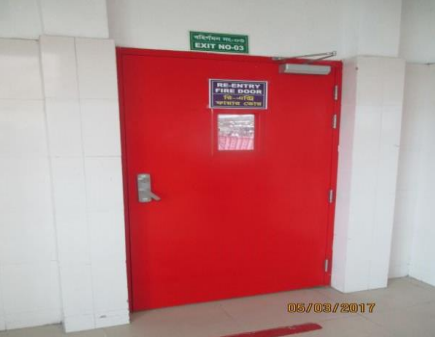
7	Some of the doors in the means of egress are collapsible.	Replace non-compliant doors and frames in the means of egress with side-swinging doors. Replacement doors shall be a minimum width of 0.8 m (32 in), and are listed, approved, self-closing, fire rated door assemblies (door and frame) with latching panic hardware.	21/11/2014	On 17/11/16: In Progress. Factory has removed all collapsible gates with locking arrangement except ground floor main gate. On 17/07/16: All non compliance gates has been replaced with side hinged swinging type doors. On 05/03/2017: All non compliance gates has been replaced with side hinged swinging type doors.	20/11/2015	Completed	Corrected

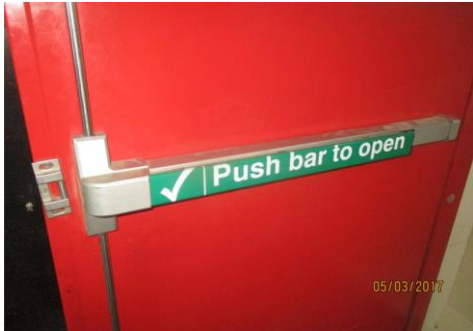
8	There are collapsible gates with locking arrangement at some egress locations.	Remove all noncompliant doors at the noted locations. Doors may be locked where the latch and lock are disengaged with one motion where the occupant load does not exceed 49 persons. Turning a door handle and disengaging a lock are considered two motions. Doors may be provided with locking hardware from the ingress side provided that a panic bar is installed on any door with an occupant load exceeding 49 persons.	14/11/2014	On 17/11/16: In Progress. Factory has removed all collapsible gates with locking arrangement except ground floor main gate. On 17/07/16: Corrected. All non compliance gates has been replaced with side hinged swinging type doors. On 05/03/2017: Corrected. All non compliance gates has been replaced with side hinged swinging type doors.	20/11/2015	Completed	Corrected

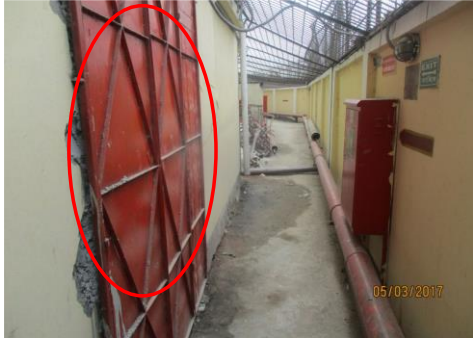
Item No	Accord Observation	Accord Recommendation	Timeline given by Accord	Comments after Physical Inspection	Supposed to complete(DD/MM/YYYY)	Final Action Plan (Factory)	Status on the date of Inspection	Pictorial Evidence
9	On the ground floor of Main Building-2, one exit discharge opens directly towards an egress court between two buildings and the boundary wall was not fire protected.	Route exits directly to the exterior or provide an exit passageway in accordance with Alliance Standard Section 6.15 or an Egress Court in accordance with Alliance Standard Section 6.17.2 for non-compliant arrangements. Consult a qualified fire protection engineer to design and/or approve the required exit passageway or egress court.	19/12/2014	On 17/11/16: No action has been taken yet. On 17/07/16: Corrected. Building 02 is fully covered with automatic sprinkler system and the north side exit court is properly separated from production floor with fire rated wall. On 05/03/2017: Corrected as per previous follow-up. However non-rated opening was observed along the egress path during the time of inspection.	30/11/2015	Completed	Corrected

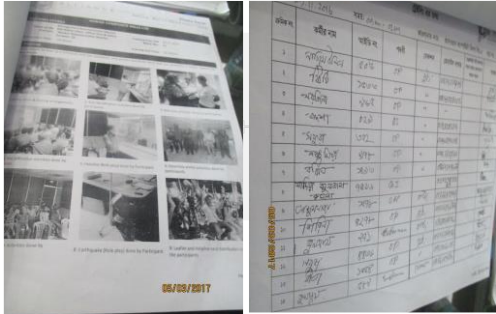
10	Required number of people were not trained and certified in fire fighting, first aid, and rescue training by the appropriate authority. A few people are trained and certified.	Train and certify at least 25 percent of workers in fire fighting, first aid and rescue training by the proper authority.	23/11/2014	On 17/11/16: Corrected. Final CAP Timeline: N/A Committed Timeline: N/A On 17/07/16: Corrected. On 05/03/2017: Corrected.	21/04/2015	Completed	Corrected

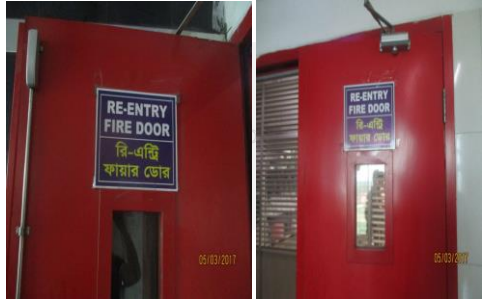
11	One of the main production buildings is 6 story, but doors are not provided with re-entry. Exit doors with re-entry are required on 5th floor (when starting at the top level).	Provide re-entry to floor levels from the stairwells in accordance with Alliance Standard Section 6.8.3.	14/11/2014	On 17/11/16: In Progress. Factory has installed the door but it is not re-entry. On 17/07/16: Corrected. Re-entry fire doors has been installed. On 05/03/2017: Corrected. Re-entry fire doors has been installed.	31/12/2015	Completed	Corrected

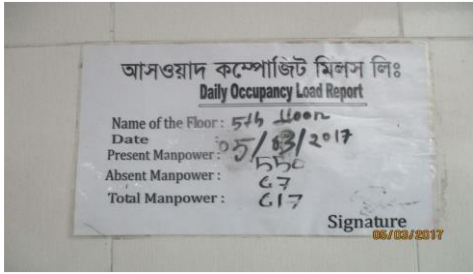
Item No	Accord Observation	Accord Recommendation	Timeline given by Accord	Comments after Physical Inspection	Supposed to complete(DD/MM/YYYY)	Final Action Plan (Factory)	Status on the date of Inspection	Pictorial Evidence
12	Occupant loads are not posted in a conspicuous space near the main exits or exit access doorways.	Post the occupant load for every assembly and production floor in a facility in a conspicuous space near the main exit or exit access doorway for the space.	14/11/2014	On 17/11/16: Corrected. Final CAP Timeline: N/A Committed Timeline: N/A On 17/07/16: Corrected. On 05/03/2017: Corrected. Provided.	21/04/2015	Completed	Corrected

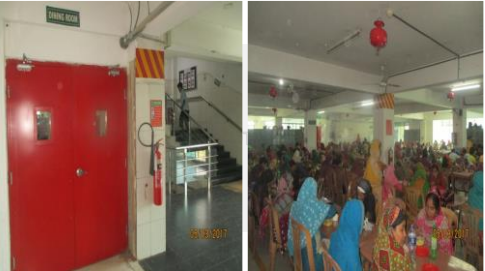
13	Occupancy separations are not provided on 2nd floor of Main Building-1 between dining, prayer room, store and production area (separated by MS grill and glass partition). These different occupancies need to be fire separated.	Provide fire-resistive rated construction barriers between hazard types in accordance with Alliance Standard Sections 3.4 and 4.5. Consult a qualified fire protection engineer to design the required rated construction barrier.	22/11/2014	On 17/11/16: In Progress. Factory has installed non listed fire rated door. On 17/07/16: Corrected. Store room has been shifted from the dining area and dining area is separated from the other hazard types areas. On 05/03/2017: Corrected. Dining area is totally separated from store room. Factory has relocated the store to building-2.	31/12/2015	Completed	Corrected

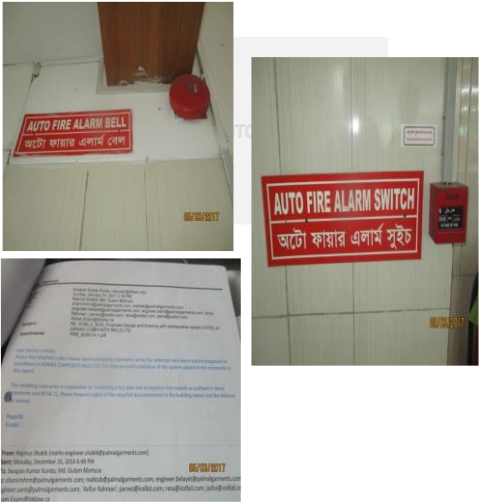
14	Automatic fire alarm and detection system is available in the factory. But currently there is no monitoring company in Bangladesh. Fire Service and Civil Defence is not also capable of monitoring fire alarm and detection systems of the factories.	Arrange for direct connection of the fire alarm system to a central monitoring station or Fire Service and Civil Defence. Until that time that monitoring can be set up, arrange a monitoring system using own central detection system and personnel. A person shall be assigned to contact the fire department in the event of fire alarm activation. An annunciator shall be located in a constantly attended location (such as a fire control room) to alert this person.	21/11/2014	On 17/11/16: In Progress. During visual inspection the installed conventional fire alarm system found faulty and it is not capable to support different interfacing module required for exhaust fans, fire doors, fire pump, lift etc. On the other hand the factory has started the process to submit the drawing in the Alliance and open L/C for fire alarm equipment and they will submit L/C to Accord within committed timeline. Final CAP Timeline: Expired. Committed Timeline: Within 30th November 2015 for drawing submit and Within 15th December 2015 for (L/C Submission). Installation of fire alarm system within 28th February 2016. On 17/07/16: As built drawing has been submitted to Alliance but still not reviewed. On 05/03/2017: Design reviewed by Alliance. Factory has shown the approval mail during the time of inspection. Installation work is in progress.	30/03/2017	Conventional Detection system are available in the factory. Now we are going to install Addressable system . - Design/Drawing submit to Alliance for revision 05 /12/2016	In Progress

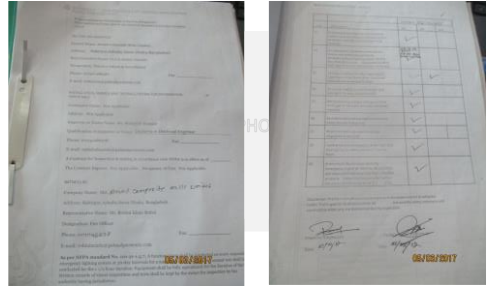
Item No	Accord Observation	Accord Recommendation	Timeline given by Accord	Comments after Physical Inspection	Supposed to complete(DD/MM/YYYY)	Final Action Plan (Factory)	Status on the date of Inspection	Pictorial Evidence
15	Record of verifying emergency power for means of egress illumination was not found as required.	Develop a testing and maintenance program that ensures the operation of all egress lighting is verified at least once per year. If battery-operated lights are used, these lights shall be tested on a monthly basis. Functional testing of battery powered lights shall be provided for a minimum 90 minutes once per year.	14/11/2014	On 17/11/16: In Progress. Record of verifying emergency power for means of egress illumination was not in accordance with NFPA or Accord standard. On 17/07/16: Corrected. On 05/03/2017: Corrected. Factory is maintaining a checklist as per standard code.	30/11/2015	Completed	Corrected

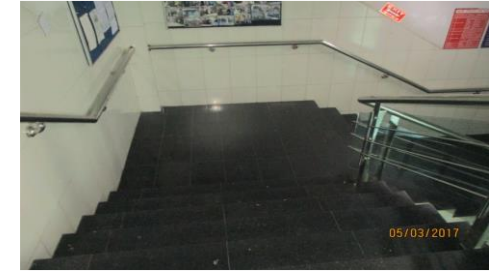
16	Handrails are not provided on both sides of each stairway.	Provide handrails on both sides of each stairway. Provide intermediate handrails when the stair width exceeds 2.2 m (87 inch). Provide a handrail of height between the range 865 mm (34 in.) and 965 mm (38 in.).	22/11/2014	On 17/11/16: Corrected. Final CAP Timeline: N/A Committed Timeline: N/A On 17/07/16: Corrected. On 05/03/2017: Corrected. Provided.	21/04/2015	Completed	Corrected

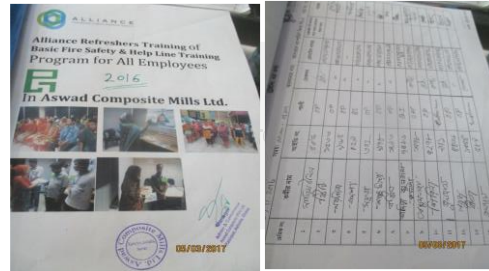
17	No record of training program is available on fire safety.	Implement training programs and document in accordance with the Alliance Safety Training Curriculum.	21/11/2014	On 17/11/16: Corrected. Final CAP Timeline: N/A Committed Timeline: N/A On 17/07/16: Corrected. On 05/03/2017: Corrected.	21/04/2015	Completed	Corrected

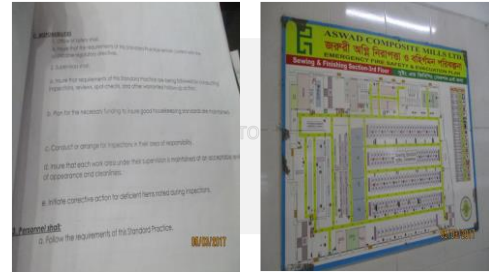
18	Through the interviews, it was noted that the workers are aware of the evacuation procedure upon commencement of the alarm. However, no procedure-defining evacuation process document was available.	Develop an emergency evacuation plan which includes all components required by the Alliance Standards and communicate the plan to all employees. The evacuation plan shall include provisions to assist physically disabled persons. A list of all employees with physical disabilities shall be kept by the Fire Service Director.	21/11/2014	On 17/11/16: Corrected. Final CAP Timeline: N/A Committed Timeline: N/A On 17/07/16: Corrected. On 05/03/2017: Corrected as per previous follow-up.	21/04/2015	Completed	Corrected

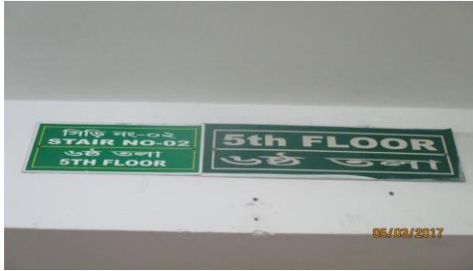
Item No	Accord Observation	Accord Recommendation	Timeline given by Accord	Comments after Physical Inspection	Supposed to complete(DD/MM/YYYY)	Final Action Plan (Factory)	Status on the date of Inspection	Pictorial Evidence
19	No record of testing emergency power for exit signs was found.	Develop a testing and maintenance program that ensures the emergency power for exit signs is tested at least once per year. If battery operated signs are used, these lights are tested on a monthly basis. Functional testing of battery powered signs is provided for a minimum 90 min once per year	21/11/2014	On 17/11/16: Corrected. Final CAP Timeline: N/A Committed Timeline: N/A On 17/07/16: Corrected. On 05/03/2017: Corrected. Factory is maintaining a checklist as per standard code.	21/04/2015	Completed	Corrected	 
20	Stair designation signs are not provided at each floor entrance from the stair to the floor in English and Bengali. Signs are not posted adjacent to the door.	Install signage adjacent to each stair door indicating the stair name and the floor level in both English and Bengali.	14/11/2014	On 17/11/16: No action has been taken yet. Final CAP Timeline: Expired. Committed Timeline: Within 30th November 2015. On 17/07/16: Corrected. On 05/03/2017: Corrected. Provided.	30/11/2015	Completed	Corrected

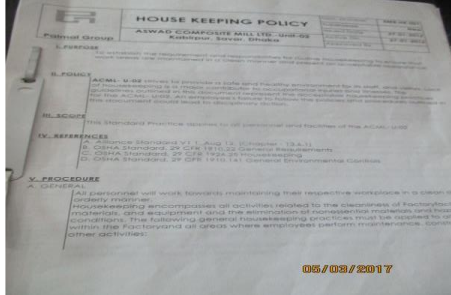
Item No	Accord Observation	Accord Recommendation	Timeline given by Accord	Comments after Physical Inspection	Supposed to complete(DD/MM/YYYY)	Final Action Plan (Factory)	Status on the date of Inspection	Pictorial Evidence
23	Written housekeeping policy was not found.	Establish written corporate and plant policies on housekeeping to ensure scheduled cleaning for floor, wall, ceiling, supply and return air ventilation systems. Promptly reschedule skipped cleanings. Provide a documented line of authority for authorizing a cleaning delay and rescheduling.	15/02/2015	On 17/11/16: Corrected. Final CAP Timeline: N/A Committed Timeline: N/A On 17/07/16: Corrected. On 05/03/2017: Corrected.	21/04/2015	Completed	Corrected

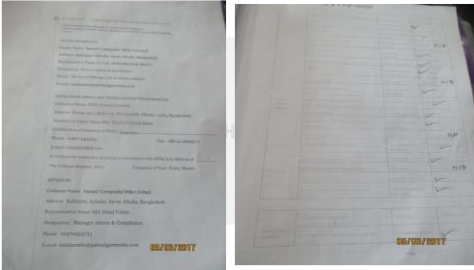
24	Inspection, maintenance, and testing procedures of the existing fire pump is not documented and up to date.	Install a pump dedicated for fire fighting or fire protection following the requirements of NFPA 20. Then establish an inspection, maintenance, and testing program for the fire pump. Program must comply with NFPA 25.	22/11/2014	On 17/11/16: In Progress. Factory has been reviewed the fire fighting drawing by Alliance. Rectification work is in progressing. On the other hand the factory will finish the rectification work within committed timeline according to Alliance reviewed drawing. On 17/07/16: It is an integrated part of fire fighting system. On 05/03/2017: Corrected. Factory is maintaining a checklist as per standard code.	15/12/2015	Completed	Corrected

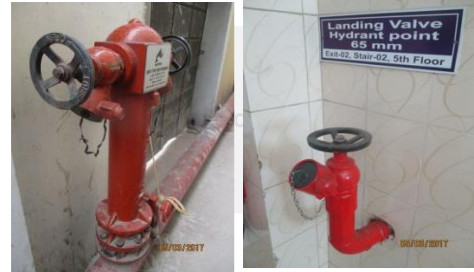
25	Class III standpipe system is not installed in the building according to NFPA 14. Signage for the available standpipe system is not installed.	Install a standpipe system at required locations designed by a qualified fire protection engineer. The system is to be compliant with the requirements of NFPA 14. Install required identification signs at the noted locations. Signage must comply with NFPA 14 Chapter 6.	22/11/2014	On 17/11/16: In Progress. It is an integrated part of fire fighting system. On 17/07/16: It is an integrated part of fire fighting system. On 05/03/2017: It is an integrated part of fire fighting system.	05/12/2015	Completed	In Progress

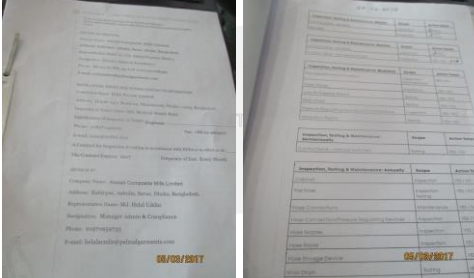
26	Class III standpipe system is not installed in the building according NFPA 14. Inspection, maintenance and testing procedures of the installed standpipe and hose are not documented and up to date.	Install class III standpipe system at required locations designed by a qualified fire protection engineer. The system is to be compliant with the requirements of NFPA 14. Then establish an inspection, maintenance, and testing program for the standpipe and hose system. Program must comply with the requirements of NFPA 14 Chapter 6 Table	22/11/2014	On 17/11/16: In Progress. It is an integrated part of fire fighting system. On 17/07/16: It is an integrated part of fire fighting system. On 05/03/2017: Factory is maintaining a checklist as per standard code.	05/12/2015	Completed	Corrected

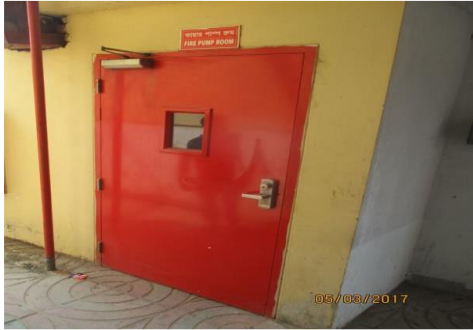
29	New Finding: Fire Pump room is not properly separated by fire rated construction with other Occupancies/Areas.	1. Fire Pump room shall be separated from other occupancies by a minimum 2-hr fire rated construction (wall, floor, slab etc). Seal all penetrations and openings (door, window etc.). Relocate it to exterior of the building and maintain a minimum 50 ft. spatial separation distance from the building.	30/12/2015	On 17/11/16: New Finding. On 17/07/16: Corrected. On 05/03/2017: Corrected. Factory has installed fire door and it was found closed during the time of inspection.	30/12/2015	Completed	Corrected

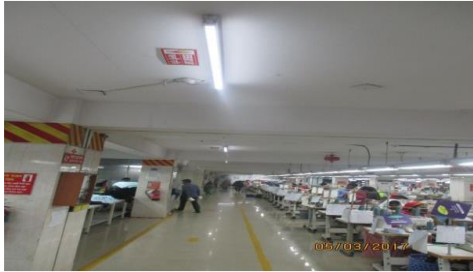
30	New Finding: Based on the number and location of emergency lights observed, adequate illumination levels are not anticipated along egress routes.	Test the emergency lighting system on each floor and provide additional emergency fixtures to provide adequate illumination along the means of egress. Provide a minimum illumination of 10 lux at the floor level within exit stairs and exit discharge paths and minimum illumination in aisle.	30/12/2015	On 17/11/16: New Finding. On 17/07/16: Corrected. On 05/03/2017: Corrected as per previous follow-up.	30/12/2015	Completed	Corrected

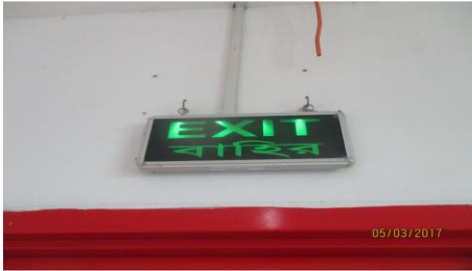
32	New Finding: Storage was observed under cutting table.	Storage underneath the cutting tables shall be kept clear of combustibles at all time as per Alliance Standard Part 17 Section 13.7.2 Cutting tables.	30/12/2015	On 17/11/16: New Finding. On 17/07/16: Corrected. On 05/03/2017: Corrected. Not found.	30/12/2015	Completed	Corrected	 
33	New Finding: Exit signage not illuminated during testing (burned out, broken, etc).	Regularly inspect all exit signage as per Accord standard and replace/install lights as needed to illuminate signs.	30/12/2015	On 17/11/16: New Finding. On 17/07/16: Corrected. On 05/03/2017: Corrected.	30/11/2015	Completed	Corrected

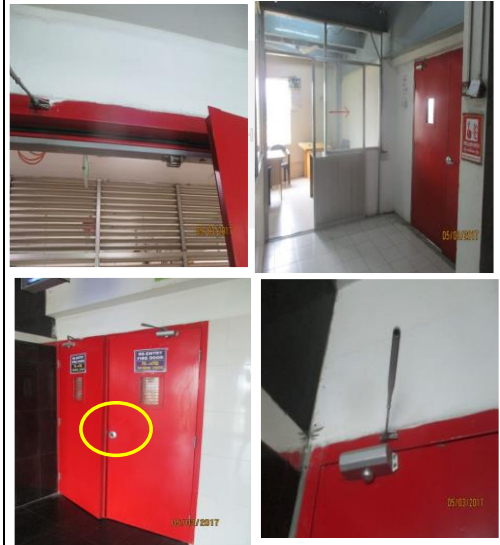
Item No	Accord Observation	Accord Recommendation	Timeline given by Accord	Comments after Physical Inspection	Supposed to complete(DD /MM/YYYY)	Final Action Plan (Factory)	Status on the date of Inspection	Pictorial Evidence
34	New Finding: The exit stairs are not separated from (work areas, other spaces) on each floor by fire-rated construction.	Stair shall be enclosed with a minimum 1.5-hr fire-rated construction. Seal all unprotected openings and provide minimum 1.5-hr fire rated doors to separate the exit stairs from work areas and other building spaces on all floor levels. Ensure that the fire doors are self-closing, positive latching and that they are provided with fire exit (panic) hardware where serving production floors. If fire doors are required to be held open for functional reasons, provide automatic-closing devices tied to the fire alarm system.	15/12/2015	On 17/11/16: New Finding, On 17/07/16: No action has been taken yet for building 02. Fire door installation is going on in building 01. Final CAP Timeline: Expired. Committed Timeline: 30/08/16 On 05/03/2017: Factory has installed fire doors at building-1 where doors were found physically damaged during the time of inspection. Door closer, coordinators, smoke seal etc. were missing for both building-1 and building-2. Fire door installation is still pending at building-2. Office room was found without proper separation at the stair landing on 1st floor of building -02.	15/12/2015	Completed	In Progress
