FIRE SAFETY FOLLOW UP INSPECTION

Factory Name	Nafa Apparels Ltd.(Former Palmal Knitwear Factory Ltd)		
Address	Hizalhati, Baroipara, Kaliakoir, Gazipur		
Inspection Date	04/09/2014		
Date Report Received	05-December/14		
Date of 1 st Follow-up	20-May/15	Date of 2 nd Follow-up	01-February/16
Date of 3 rd Follow-up	17-April/16	Date of 4 th Follow-up	08-June/16
Date of 5 th Follow-up	25-October/16	Date of 6 th Follow-up	
Inspected by	Mahfuza Khanom

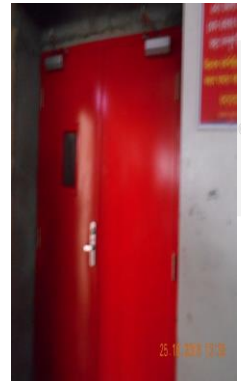
2	<p>Areas used for combustible storage are not separated by fire-rated construction.</p> <p>Locations: -Storage rooms on all floors with ventilation ports along the walls and open, gated doors that compromise the fire barrier. -General storage on multiple floors was open to production areas</p>	<p>Provide dedicated storage rooms separated by minimum 1-hr fire-rated construction. Where separate storage rooms are not feasible, provide defined storage areas and limit the storage arrangement as follows: - Maximum height of 2.4m and maximum area of 23m² - If sprinkler protected: maximum height of 3.66m and maximum area of 93m² Separate areas of unenclosed combustible storage by a minimum clear distance of 3m.</p>	Within 3 Month	<p>On 01/02/2016: No action has been taken yet.</p> <p>On 17/04/2016: Partially Corrected. Store separation work is almost finished. Factory personnel informed that, remaining work will be finished within a week.</p> <p>On 08-06-16: Corrected. The factory management has sent the pictures of door installation work after finishing the remaining work which was left during the time of inspection. If the factory wants to keep the doors open than they have to use magnetic door holder interfaced with fire alarm control panel.</p> <p>On 25/10/2016: Corrected as per previous follow-up.</p>	10/05/2016	Completed	Corrected

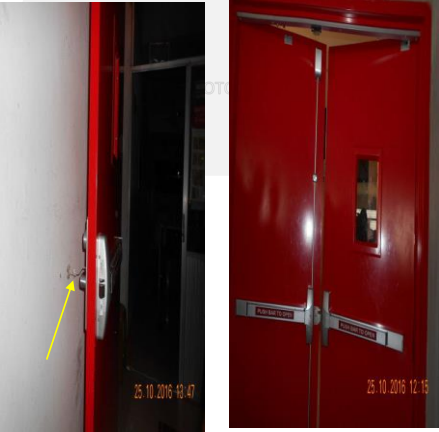
Item No	Accord Observation	Accord Recommendation	Timeline given by Accord	Comments after Physical Inspection	Supposed to complete (DD/MM/YYYY)	Final Action Plan (Factory)	Status on the date of Inspection	Pictorial Evidence
3	The exit stairs are not separated from work areas and other spaces on each floor by fire-rated construction.	<p>Provide minimum 1.5-hr fire rated doors and seal all unprotected openings to separate the exit stairs and bridge from work areas and other building spaces on all floor levels. Ensure that the fire doors are self-closing and positive latching and that they are provided with fire exit (panic) hardware where serving production floors.</p> <p>If fire doors are required to be held open for functional reasons, provide automatic closing devices tied to the fire alarm system.</p>	Within 3 Month	<p>On 01/02/2016: Fire rated door installation is going on. Some non listed installed fire door has been found during 2nd follow up inspection.</p> <p>On 17/04/2016: Partially Corrected. Fire rated doors are installed for all the required exits to protect the exit enclosures but some civil related works still left, during inspection those found in-process. The external stair is also not fully protected yet as there are un-protected openings available within 10 ft.</p> <p>On 08-06-16: Partially corrected. Office room at ground floor and both roof should be provided with fire rated separation. If the factory wants to keep the doors open than they have to use magnetic door holder interfaced with fire alarm control panel.</p> <p>On 25/10/2016: Partially corrected. The factory has installed most of the fire rated doors. But during follow-up inspection fire door has been observed open with external source. If the factory wants to keep the door open, they will require to install automatic door holder interfaced with FACP system. The factory will require to provide proper certification for the fire rating of installed gypsum board. Mechanical malfunction has also been observed in few fire doors.</p>	10/05/2017	Fire Door in hand , work already started and will be completed before 15/10/16	In Progress

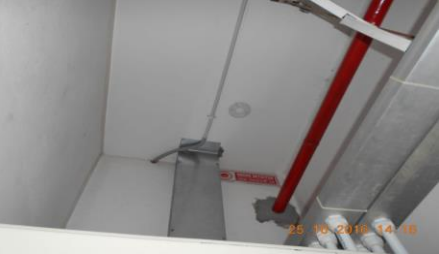
4	<p>Unsealed penetrations and openings are located in the fire-rated floor/ceiling assemblies.</p> <p>Location: All floors</p>	<p>Provide a minimum 2-hr fire-rated shaft to separate the utility risers from each floor level.</p> <p>Seal all penetrations and openings in floor/ceiling assemblies to maintain the fire separation.</p>	Within 3 Month	<p>On 01/02/2016: Some penetrations have been sealed properly and till now some penetrations are not sealed.</p> <p>On 17/04/2016: Corrected. During inspection no such kind of penetration observed at any floor.</p> <p>On 08-06-16: Corrected. During inspection no such kind of penetration observed at any floor.</p> <p>On 25/10/2016: Corrected. Unsealed opening and penetration has not been observed during follow-up inspection.</p>	17/04/2016	Corrected	Corrected

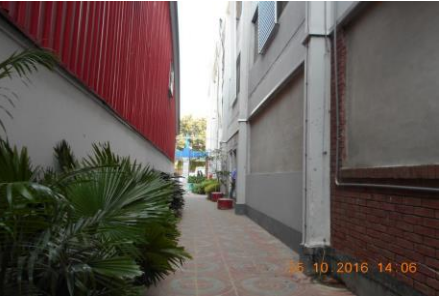
5	<p>Areas used for combustible storage are not separated by fire-rated construction.</p> <p>Location: Storage/godown shed approximately 10 feet from the north side of the main building.</p>	<p>Provide dedicated storage rooms separated by minimum 1-hr fire-rated construction.</p> <p>Where separate storage rooms are not feasible, provide defined storage areas and limit the storage arrangement as follows:</p> <ul style="list-style-type: none"> - Maximum height of 2.4m and maximum area of 23m² - If sprinkler protected: maximum height of 3.6m and maximum area of 93m² <p>Separate areas of unenclosed combustible storage by a minimum clear distance of 3m.</p>	Within 3 Month	<p>On 01/02/2016: Fire rated construction has been completed but fire rated door is not installed at training center and store room.</p> <p>On 17/04/2016: Corrected</p> <p>On 08-06-16: Corrected.</p> <p>On 25/10/2016: Corrected as per previous follow-up inspection.</p>	17/04/2016	Corrected	Corrected

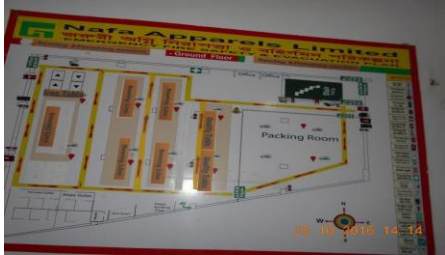
Item No	Accord Observation	Accord Recommendation	Timeline given by Accord	Comments after Physical Inspection	Supposed to complete (DD/MM/YYYY)	Final Action Plan (Factory)	Status on the date of Inspection	Pictorial Evidence
9	Evacuation plans on various floors do not indicate use of an outside exit stair which is marked as an exit.	Update evacuation plans to indicate relevant exits and to provide adequate exit knowledge.	Within 1 Months	On 01/02/2016: Corrected On 17/04/2016: Corrected On 08-06-16: Corrected. On 25/10/2016: Corrected.	12/06/2014	Corrected	Corrected

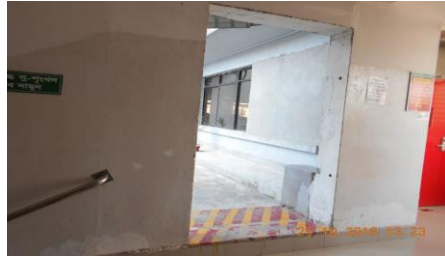
10	Exit stair door does not swing in the direction of egress travel. Locations: Doors leading to exit stairs from rooftop of the three story portion of the building.	Modify the egress door to swing in the direction of egress travel.	Within 3 Months	On 01/02/2016: Corrected. Door was not found during 2nd follow up inspection. On 17/04/2016: Corrected On 08-06-16: Corrected. Door was not found during the time of inspection. On 25/10/2016: Corrected.	12/06/2014	Corrected	Corrected

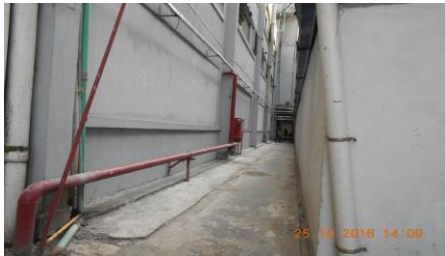
11	Exit discharge path along west side of building is an egress court less than 10 feet wide.	Provide minimum 1-hr fire-rated factory exterior wall up to 10ft above grade. Seal and/or protect all openings to maintain the required fire separations.	Within 3 Months	On 01/02/2016: Fire rated construction is almost completed except installation of fire rated door. On 17/04/2016: Partially Corrected. Only wastage storage area not protected properly, other than that the noted egress court is safe. On 08-06-16: Corrected. If the factory wants to keep the compressor room door open than they have to use magnetic door holder interfaced with fire alarm control panel. On 25/10/2016: Corrected.	10/05/2016	Completed	Corrected

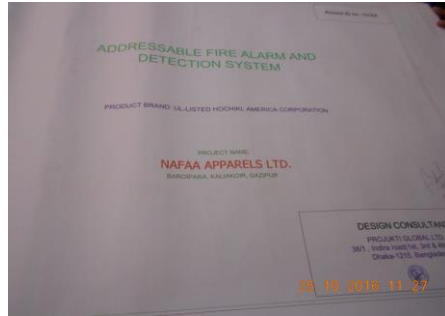
12	The fire alarm system is antiquated, not a listed system, and does not provide alarm and notification features consistent with acceptable standards.	Replace the fire alarm system with a new, listed addressable fire alarm system in accordance with NFPA 72.	Within 3 Months	On 01/02/2016: Reviewed drawing from Accord was available during 2nd follow-up inspection and installation has been started. On 17/04/2016: Installation is almost in finishing stage. On 08-06-16: Partially corrected. Reviewed drawing from Accord was available during 3rd follow-up inspection. Installation was almost completed. Fire doors, HVAC system, fire pump controls should be interfaced with FACP if applicable. Factory have to prove whether the installed fire alarm cable has been certified by any third party or not. The factory management should submit the checklist provided through email during the time of inspection. (Commissioning of the system in-front of contractor/ 3rd party will be done by Accord). On 25/10/2016: The reviewed drawing of fire alarm system from Accord was available during 5th follow-up inspection. Interfacing work has not been started yet.	30/06/2016		In Progress

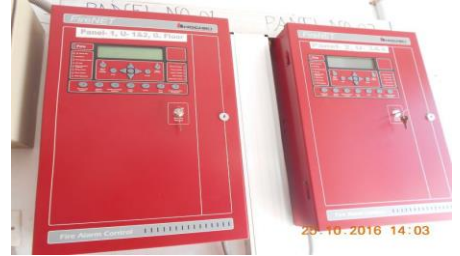
Item No	Accord Observation	Accord Recommendation	Timeline given by Accord	Comments after Physical Inspection	Supposed to complete (DD/MM/YYYY)	Final Action Plan (Factory)	Status on the date of Inspection	Pictorial Evidence
13	A fire alarm system did not appear to be in the storage/godown shed; therefore, alarm and notification features consistent with acceptable standards are not provided.	Install a new, listed addressable fire alarm system in accordance with NFPA 72.	Within 3 Months	On 01/02/2016: It is an integrated part of the fire alarm system. On 17/04/2016: Its an integrated part of fire alarm system On 08-06-16: It is an integrated part of fire alarm system. On 25/10/2016: It is an integrated part of fire alarm system.	30/06/2016		In Progress

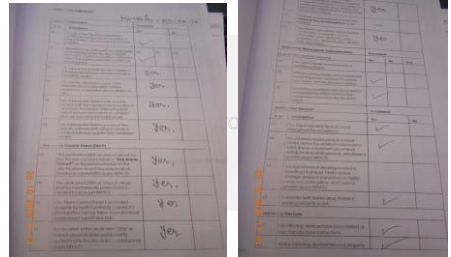
14	Inspection, testing, and maintenance records for the fire alarm system were not available.	Inspect, test and maintain the fire alarm system, and keep written records on-site, in accordance with NFPA 72.	Within 3 Months	On 01/02/2016: It is an integrated part of the fire alarm system. On 17/04/2016: It is an integrated part of fire alarm system. On 08-06-16: Corrected. On 25/10/2016: Corrected. The factory is maintaining a checklist as per NFPA 72 for the existing fire alarm system.	10/05/2016	Completed	Corrected

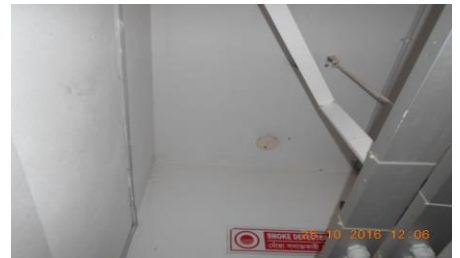
15	The building is equipped with single-station smoke alarms. Smoke alarm activation sounds only a local alarm and does not provide automatic fire alarm notification of occupants.	Replace the single-station smoke alarms with automatic smoke detectors tied into the fire alarm system. Configure the fire alarm system to initiate occupant notification upon activation of any two smoke detectors in addition to the manual fire alarm stations.	Within 6 Months	On 01/02/2016: It is an integrated part of the fire alarm system. On 17/04/2016: It is an integrated part of the fire alarm system. On 08-06-16: It is an integrated part of fire alarm system. On 25/10/2016: It is an integrated part of fire alarm system.	30/06/2016		In Progress

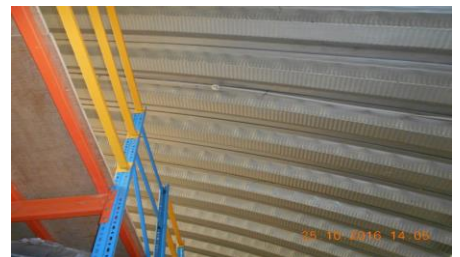
16	The storage/godown shed did not appear to be equipped with smoke alarms.	Install automatic smoke detectors tied into the fire alarm system. Configure the fire alarm system to initiate occupant notification upon activation of any two smoke detectors in addition to the manual fire alarm stations.	Within 6 Months	On 01/02/2016: It is an integrated part of the fire alarm system. On 17/04/2016: It is an integrated part of the fire alarm system. On 08-06-16: It is an integrated part of fire alarm system. On 25/10/2016: It is an integrated part of fire alarm system.	30/06/2016		In Progress
