ELECTRICAL SAFETY FOLLOW UP INSPECTION REPORT (4TH)

| Factory Name | Safaa Sweaters Ltd. | | | Note: | Modification work is going on LPS due to installation of new railing on parapet wall. |
| FACTORY ID | 12362 | ELECTRICAL SAFETY INSPECTION DATES | | | Other Factory: |

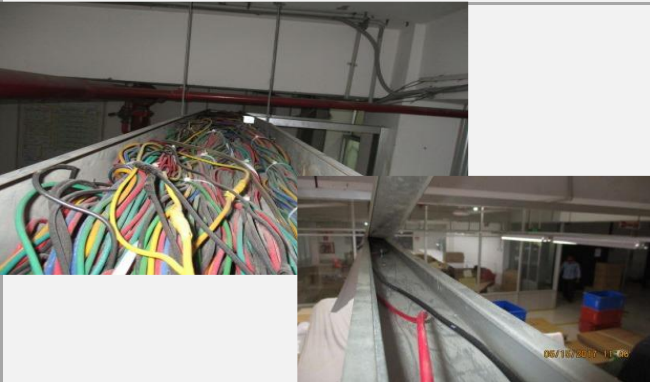
| Item No | Accord Inspection Observation | Accord Action Plan (Recommendation) | Accord Time line (given in report) | Comments from Accord (After Physical Inspection) | Final Timeline (Approved timeline) | Final Action Plan (Factory) | Progress Status (On the date of inspection) | Pictorial Evidence |
|---|---|--|---|---|---|---|---|--|
| 25 | New Finding: Cable tray overloaded with excessive cables has no cover on top of it. | Replace cable tray by wider one; or use additional cable tray to distribute cables thus 20-25% tray area are kept free. Cover the cable tray to keep it free from lint & dust. | 2 Months | On 19/07/2016: Not corrected. On 21/12/2016: Not Corrected. On 15/05/2017: Corrected | 15/07/2016 | | Corrected | |
