Structural Safety Inspection

Factory Name	Safaa Sweaters Ltd	Accord ID	12362
Factory Address	Begumpur, Bokran, Monipur, Bhawl Gore		
Inspection Date	18/10/2015		
Date of Review Inspection	15-May-17		
Inspected by	Sudip Kumar Sarker

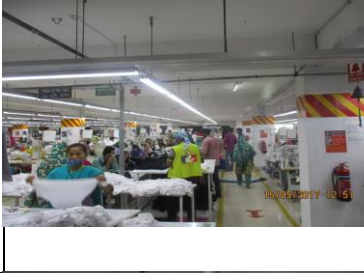
5	Stress levels in Columns	Continue to implement load plan	6-months	Completed Accord has approved Design report on 26/06/2016. Load Plan is managing at facgtoty by weekly monitoign and keeping record on book.	26/06/2016	On 19-July-2016: During inspection load was found under the design limit and load plan was posted on floor. Factory is required to maintain the load according to the load plan. On 15-May-2017: Corrected in the previous follow up inspection report. Load plan was prepared and submitted to ACCORD. Engineering assessment report along with with load plan was accepted by ACCORD. During inspection load plan was found posted in each floor and the load was within the limit as per accepted load plan	Corrected
