FIRE SAFETY FOLLOW UP INSPECTION

Factory Name	Safaa Sweaters Ltd		
Address	Begumpur, Bokran, Monipur, Bhawl Gore		
Inspection Date	10/14/2015		
Date Report Received			
Date of 1 st Follow-up	24-May/16	Date of 2 nd Follow-up	19-July/16
Date of 3 rd Follow-up	21-December/16	Date of 4 th Follow-up	
Date of 5 th Follow-up		Date of 6 th Follow-up	
Inspected by	Mahfuza Khanom

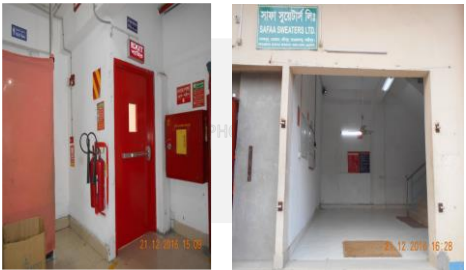
Item No	Accord Observation	Accord Recommendation	Timeline given by Accord	Comments after Physical Inspection	Supposed to complete (DD/MM/YYYY)	Final Action Plan (Factory)	Status on the date of Inspection	Pictorial Evidence
4	Egress doors and gates on the ground floor with locking features are provided at building exits. ☐	Remove locking features from all egress doors and gates. ☐ If locks are required for security reasons, utilize special door locking features complying with ACCORD standard 6.8.2.	Immediately	<p>On 24/05/2016: Corrected. Factory has removed non-compliant locking features from egress routes exit doors/gates.</p> <p>On 19/07/2016: Corrected. No such locking features were found during the time of 2nd follow-up inspection.</p> <p>On 21/12/2016: Corrected. Non-compliant locking feature has not been observed during follow-up inspection.</p>	25/12/2015	Corrected	Corrected

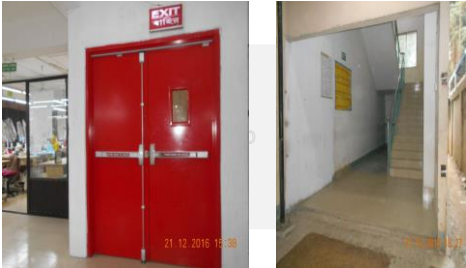
5	Collapsible gates and sliding doors on the ground floor are provided at building exits. ☐	Replace all gates and sliding doors along the means of egress with side-hinged, swinging egress doors in accordance with ACCORD standard 6.8.1. ☐	Within 1 month	<p>On 24/05/2016: Corrected. Factory has removed non-compliant doors/gates from egress routes.</p> <p>On 19/07/2016: Corrected. No non-compliant gates were found during the follow-up inspection.</p> <p>On 21/12/2016: Corrected. Non-compliant gate has not been observed during follow-up inspection.</p>	15/01/2016	Corrected	Corrected

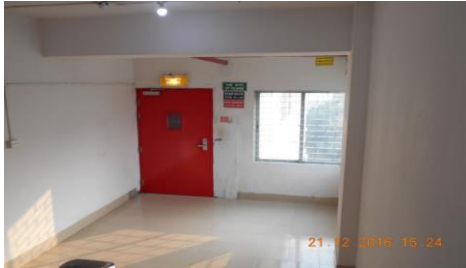
6	Each Exit stair serves more than 5 stories and do not have required re-entry provisions. ☐	Every door in a stair enclosure serving more than 5 stories shall be provided with re-entry unless it meets ACCORD standard 6.8.3.1.	Within 3 months	<p>On 24/05/2016: Corrected. Re-entry provision has been provided.</p> <p>On 19/07/2016: Corrected. Factory has provided re-entry provisions on required floors.</p> <p>On 21/12/2016: Corrected as per previous follow-up inspection.</p>	15/01/2016	corrected	Corrected

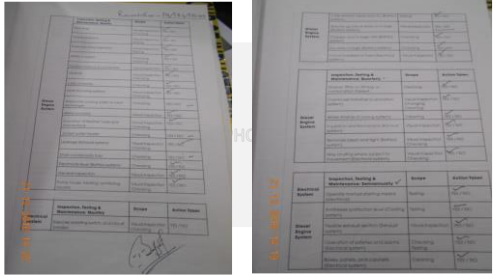
Item No	Accord Observation	Accord Recommendation	Timeline given by Accord	Comments after Physical Inspection	Supposed to complete (DD/MM/YYYY)	Final Action Plan (Factory)	Status on the date of Inspection	Pictorial Evidence
12	Inspection, testing and maintenance of the fire pump system is not in accordance with NFPA 13.	Inspect, test and maintain the fire pump system and keep written records on-site, in accordance with NFPA 20 and ACCORD standards.	Within 3 months	<p>On 24/05/2016: Factory management confirms that they will inspect, test and maintain as per standard when the new fire pump system will be installed within 30th August, 2016.</p> <p>On 19/07/2016: Corrected. Factory is maintaining a standard checklist as per code.</p> <p>On 21/12/2016: Corrected as per previous follow-up inspection.</p>	07/06/2016	Done	Corrected

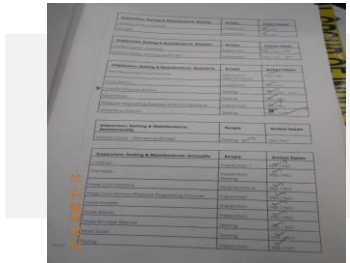
14	Inspection, testing and maintenance of the standpipe system is not in accordance with NFPA 14.	Inspect, test and maintain the standpipe system and keep written records on-site, in accordance with NFPA 14 and ACCORD standards.	Within 3 months	<p>On 24/05/2016: Factory management confirms that they will inspect, test and maintain as per standard when the new standpipe system will be installed within 30th August, 2016.</p> <p>On 19/07/2016: Corrected. Factory is maintaining a standard checklist as per code.</p> <p>On 21/12/2016: Corrected as per previous follow-up inspection.</p>	07/06/2016	Done	Corrected

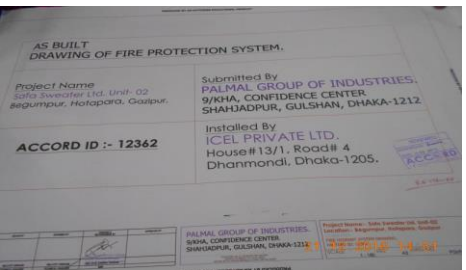
15	Standpipe system is required for the building, which has an occupiable floor 10 m (33 ft) or more above grade.	Install a new class III standpipe system in accordance with ACCORD standard 5.4 and NFPA 14. A class I system shall be permitted in buildings protected throughout by an approved automatic sprinkler system.	Within 6 months	<p>On 24/05/2016: Factory management confirms that they will re-submit standpipe system drawing to Accord within 15th June, 2016 & installation will be completed within 30th August, 2016 .</p> <p>On 19/07/2016: ACCORD reviewed design was found during the 2nd follow-up inspection. Installation is almost completed. Factory didn't change the fire pump yet. They informed that they will finish the overall installation within 30th November 2016.</p> <p>On 21/12/2016: The reviewed drawing of fire alarm system was present during 3rd follow-up inspection. L/C for fire pump has not been opened yet.</p>	30/08/2016	Drawing reviewed by ACCORD on 14/07/2016. Installation completed.	In Progress

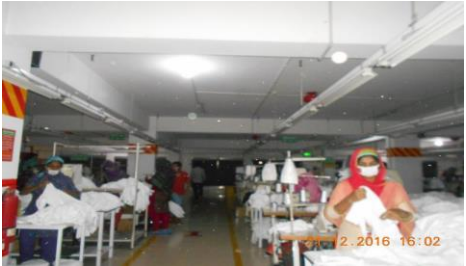
Item No	Accord Observation	Accord Recommendation	Timeline given by Accord	Comments after Physical Inspection	Supposed to complete (DD/MM/YYYY)	Final Action Plan (Factory)	Status on the date of Inspection	Pictorial Evidence
20	New Finding in 2nd follow-up: Exit signage and emergency lights were not illuminated during testing (damaged, burned out, broken, etc.).	Regularly inspect all exit signage as per Accord standard and replace/install lights as needed to illuminate signs.	Within 1 month	On 19/07/2016: New Finding On 21/12/2016: Corrected.	19/08/2016	Completed, Verification Pending	Corrected	   
21	New Finding in 2nd follow-up: Based on the number and location of emergency lights observed, adequate illumination levels are not anticipated along egress routes.	Test the emergency lighting system on each floor and provide additional emergency fixtures to provide adequate illumination along the means of egress. Provide a minimum illumination of 10 lux at the floor level within exit stairs and exit discharge paths and minimum 2.5 lux along exit access aisles.	Within 1 month	On 19/07/2016: New Finding On 21/12/2016: Corrected. Adequate illumination has been observed during follow-up inspection.	19/08/2016	Completed, Verification Pending	Corrected

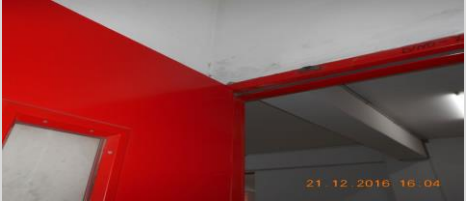
22	New Finding (3rd Follow Up): During follow-up inspection it has been observed that the exit stairs are not properly separated from [work areas, other spaces] on each floor by fire rated construction due to improper fire door accessories (malfunction of door coordinator, missing vision panel and door closer).	Seal all unprotected openings to separate the exit stairs from work areas and other building spaces on all floor levels. Ensure the proper installation of fire door accessories and the fire doors are self-closing and positive latching. If fire doors are required to be held open for functional reasons, provide automatic-closing devices tied to the fire alarm system.	Within 1 month	On 21/12/2016: New Finding	21-01-2017
