**FIRE SAFETY FOLLOW UP INSPECTION**

<b>Factory Name</b>	Safaa Sweaters Ltd		
<b>Address</b>	Begumpur, Bokran, Monipur, Bhawl Gore		
<b>Inspection Date</b>	10/14/2015		
<b>Date Report Received</b>			
<b>Date of 1<sup>st</sup> Follow-up</b>	24/May/16	<b>Date of 2<sup>nd</sup> Follow-up</b>	19/July/16
<b>Date of 3rd Follow-up</b>	21/December/16	<b>Date of 4th Follow-up</b>	15th may 2017
<b>Date of 5th Follow-up</b>		<b>Date of 6th Follow-up</b>	
<b>Inspected by</b>	Dalower Hossain

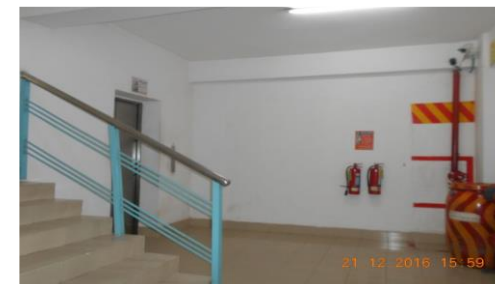
The elevator does not have the proper fire rating for the elevator door.

On 24/05/2016: Corrected. Factory has sealed openings near elevators.  
On 19/07/2016: Corrected. Factory has sealed the openings and penetrations near elevator.

Provide the proper 2 hr fire rating for the shaft and 1.5 hr fire rating for the elevator door.

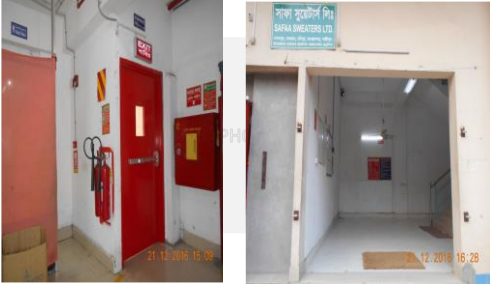
4	Egress doors and gates on the ground floor with locking features are provided at building exits.	Remove locking features from all egress doors and gates. If locks are required for security reasons, utilize special door locking features complying with ACCORD standard 6.8.2.	Immediately	<p>On 24/05/2016: Corrected. Factory has removed non-compliant locking features from egress routes exit doors/gates.</p> <p>On 19/07/2016: Corrected. No such locking features were found during the time of 2nd follow-up inspection.</p> <p>On 21/12/2016: Corrected. Non-compliant locking feature has not been observed during follow-up inspection.</p> <p>On 15/05/2017 : Corrected.</p>	25/12/2015	Corrected	Corrected

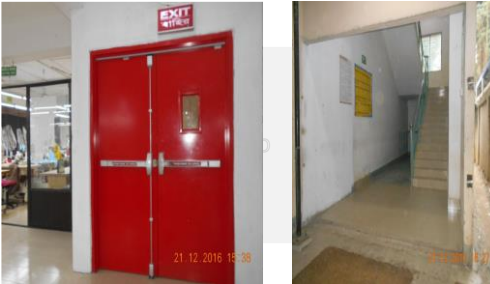
5	Collapsible gates and sliding doors on the ground floor are provided at building exits.	Replace all gates and sliding doors along the means of egress with side-hinged, swinging egress doors in accordance with ACCORD standard 6.8.1.	Within 1 month	<p>On 24/05/2016: Corrected. Factory has removed non-compliant doors/gates from egress routes.</p> <p>On 19/07/2016: Corrected. No non-compliant gates were found during the follow-up inspection.</p> <p>On 21/12/2016: Corrected. Non-compliant gate has not been observed during follow-up inspection.</p> <p>On 15/05/2017 : Corrected.</p>	15/01/2016	Corrected	Corrected

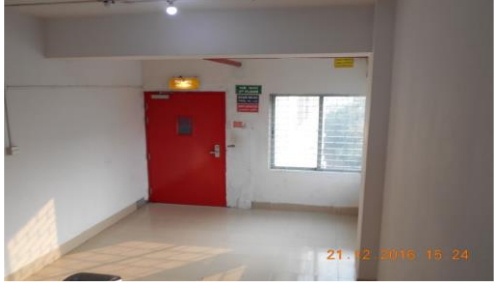
Item No	Accord Observation	Accord Recommendation	Timeline given by Accord	Comments after Physical Inspection	Supposed to complete (DD/MM/YYYY)	Final Action Plan (Factory)	Status on the date of Inspection	Pictorial Evidence
6	Each Exit stair serves more than 5 stories and do not have required re-entry provisions.	Every door in a stair enclosure serving more than 5 stories shall be provided with re-entry unless it meets ACCORD standard 6.8.3.1.	Within 3 months	<p>On 24/05/2016: Corrected. Re-entry provision has been provided.</p> <p>On 19/07/2016: Corrected. Factory has provided re-entry provisions on required floors.</p> <p>On 21/12/2016: Corrected as per previous follow-up inspection.</p> <p>On 15/05/2017 : Corrected.</p>	15/01/2016	corrected	Corrected

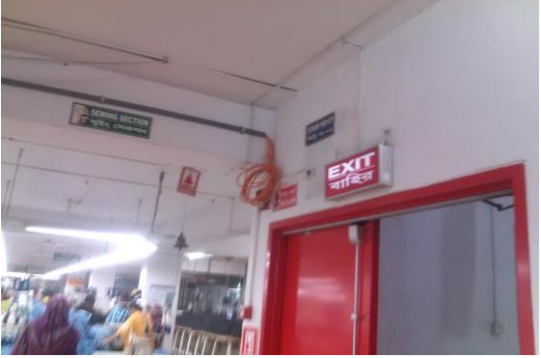
7	Fire alarm system installation requires detailed review to confirm compliance with NFPA 72 and ACCORD standards.	Submit as-built drawings, testing records, equipment certification and other relevant documentation to the ACCORD for review and approval.	Within 1 month	<p>On 24/05/2016: Factory management confirms that they will re-submit fire alarm system drawing to Accord within 25th May, 2016 &amp; modification will be completed within 30th August, 2016 .</p> <p>On 19/07/2016: Factory has re-submitted the design of fire alarm and detection system for review on 25th April 2016. Installation is still pending for 1st and ground floor. Factory has informed that they will finish the overall installation work within 30th September 2016.</p> <p>On 21/12/2016: The drawing of fire alarm system has been rejected on 12-12-2016. The factory has informed that they will re-submit the drawing within very short time.</p> <p>On 15/05/2017 : Installation has been in progress.</p>	30/08/2016	Design/Drawing under reviewed by ACCORD. Revised CFDS drawing resubmitted to ACCORD on 20/11/2016	In Progress

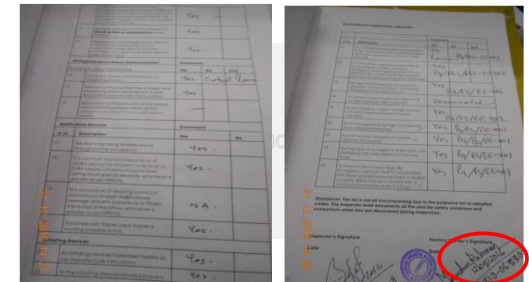
10 Inspection, testing and maintenance for the fire alarm system is not in accordance with NFPA 72.

On 24/05/2016: Factory management is keeping maintenance records on-site for their existing system and confirms that they will inspect, test and maintain as per standard when the new fire alarm system will be installed within 30th August, 2016.  
 On 19/07/2016: Corrected. Factory is maintaining a standard checklist as per code.  
 On 21/12/2016: Corrected as per previous follow-up inspection.  
**Note: The factory has provided a checklist as per standard but it was not upto date.**  
 On 15/05/2017 : Corrected.

Inspect, test and maintain the fire alarm system and keep written records on-site, in accordance with NFPA 72 and ACCORD standards.

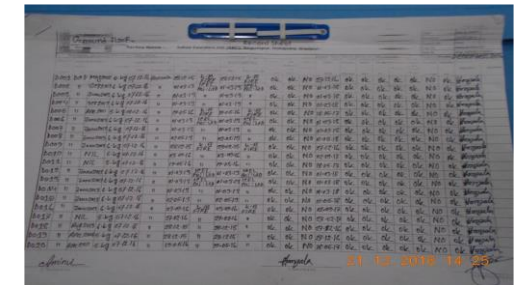
11 Inspection, testing and maintenance of portable fire extinguishers is not in accordance with NFPA 10.

On 24/05/2016: Corrected. Note: Factory should update fire extinguisher maintenance checklist.  
 On 19/07/2016: Corrected. Factory is maintaining a standard checklist as per code.  
 On 21/12/2016: Corrected as per previous follow-up inspection.  
 On 15/05/2017 : Corrected.

Inspect, test and maintain the portable fire extinguishers and keep written records on-site, in accordance with NFPA 10 and ACCORD standards.

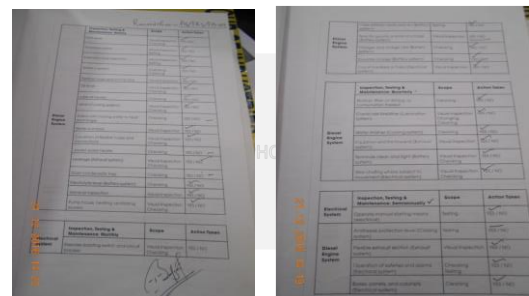
12 Inspection, testing and maintenance of the fire pump system is not in accordance with NFPA 20 and ACCORD standards.

On 24/05/2016: Factory management confirms that they will inspect, test and maintain as per standard when the new fire pump system will be installed within 30th August, 2016.  
 On 19/07/2016: Corrected. Factory is maintaining a standard checklist as per code.  
 On 21/12/2016: Corrected as per previous follow-up inspection.  
 On 15/05/2017 : Corrected.

Inspect, test and maintain the fire pump system and keep written records on-site, in accordance with NFPA 20 and ACCORD standards.

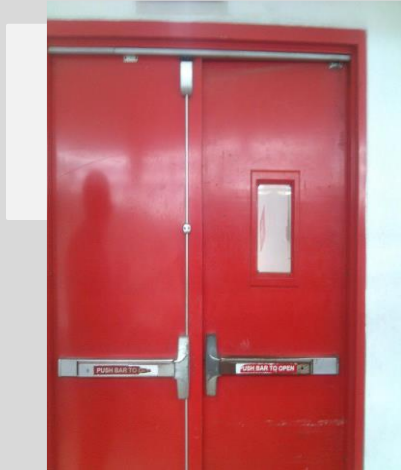
Item No	Accord Observation	Accord Recommendation	Timeline given by Accord	Comments after Physical Inspection	Supposed to complete (DD/MM/YYYY)	Final Action Plan (Factory)	Status on the date of Inspection	Pictorial Evidence
22	New Finding (3rd Follow Up): During follow-up inspection it has been observed that the exit stairs are not properly separated from [work areas, other spaces] on each floor by fire rated construction due to improper fire door accessories (malfunction of door co-ordinator, missing vision panel and door closer).	Seal all unprotected openings to separate the exit stairs from work areas and other building spaces on all floor levels. Ensure the proper installation of fire door accessories and the fire doors are self-closing and positive latching. If fire doors are required to be held open for functional reasons, provide automatic-closing devices tied to the fire alarm system.	Within 1 month	On 21/12/2016: New Finding On 15/05/2017 : It is found same as before.	21/01/2017		In Progress
