**ELECTRICAL SAFETY FOLLOW UP INSPECTION REPORT (8TH)**

<b>Factory Name</b>	<b>ASWAD COMPOSITE MILLS LTD. ( U-2)</b>					<b>Note:</b>
<b>Address</b>	Kabirpur, Ashulia, Savar					
<b>FACTORY ID</b>	<b>11095</b>	<b>ELECTRICAL SAFETY INSPECTION DATES</b>				<b>Other Factory:</b>
<b>Initial Inspection Date</b>	08/05/2014	Date of 5 <sup>th</sup> Follow Up	11/09/2017	Date of 11 <sup>th</sup> Follow Up		
<b>Report Received Date</b>	21/04/2015	Date of 6 <sup>th</sup> Follow Up	12/03/2018	Date of 12 <sup>th</sup> Follow Up		
Date of 1 <sup>st</sup> Follow Up	17/11/2015	Date of 7 <sup>th</sup> Follow Up	31/07/2018	Date of 13 <sup>th</sup> Follow Up		
Date of 2 <sup>nd</sup> Follow Up	17/07/2016	Date of 8 <sup>th</sup> Follow Up	27/01/2019	Date of 14 <sup>th</sup> Follow Up		
Date of 3 <sup>rd</sup> Follow Up	05/03/2017	Date of 9 <sup>th</sup> Follow Up		Date of 15 <sup>th</sup> Follow Up		
Date of 4 <sup>th</sup> Follow Up	31/05/2017	Date of 10 <sup>th</sup> Follow Up		Date of 16 <sup>th</sup> Follow Up

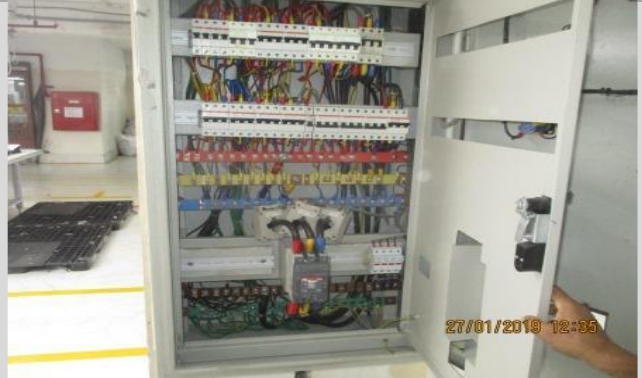
49	<p><b>New Finding:</b> Inadequate working space around transformer for performing maintenance work</p>	<p>Minimum working space (1.07m) around the transformer (and related electrical installations) must be maintained</p>	1 Month		04/02/2019
