**FIRE SAFETY FOLLOW UP INSPECTION**

Factory Name	Safaa Sweaters Ltd		Accord ID	12362
Address	Begumpur, Bokran, Monipur, Bhawl Gore			
Inspection Date	14/10/2015		Report Received Date	
Date of 1st Follow-up	24/05/2016	Date of 2nd Follow-up	19/07/2016	
Date of 3rd Follow-up	21/12/2016	Date of 4th Follow-up	15/05/2017	
Date of 5th Follow-up	04/01/2018	Date of 6th Follow-up	24/07/2018	
Date of 7th Follow-up	28/01/2019	Date of 8th Follow-up		
Date of 9th Follow-up		Date of 10th Follow-up		
Date of 11th Follow-up		Date of 12th Follow-up		
Date of 13th Follow-up		Date of 14th Follow-up		
Inspected by	Md. Anayet Hossain & Rafat Arefin.

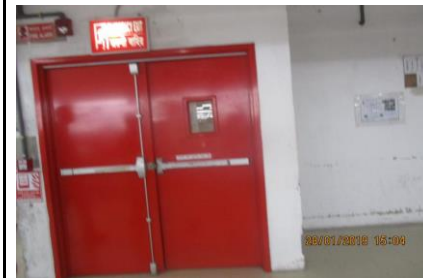
Item No	Accord Observation	Accord Recommendation	Timeline given by Accord	Comments after Physical Inspection	Supposed to complete(D/D/MM/YYYY)	Final Action Plan (Factory)	Status on the date of Inspection	Pictorial Evidence
1	Proper certification was not available for fire rated doors installed in the factory.	Submit proper certifications for installed fire doors to the ACCORD for approval. If not available, or certification is not approved, install new, properly certified fire rated doors in accordance with ACCORD direction.	Immediately	<p>On 24/05/2016: Factory has installed fire door in factory building premises. During follow up inspection third party certification (UL) level was found on door leaf &amp; accessories except door frame. Note: Doors which are needed to keep open, shall be interface (by electro-magnetic door holder device) with fire alarm control panel at required location.</p> <p>On 19/07/2016: Factory has shown the 3rd party certification as well as the approval mail conversation with Alliance.</p> <p>On 21/12/2016: Corrected as per previous follow-up inspection.</p> <p>On 15/05/2017 : Corrected.</p> <p>On 04/January/2018: Corrected</p> <p>On 24/07/2018: Corrected.</p> <p><b>On 28/01/2019: Corrected.</b></p>	'10/06/2016	Done	Corrected

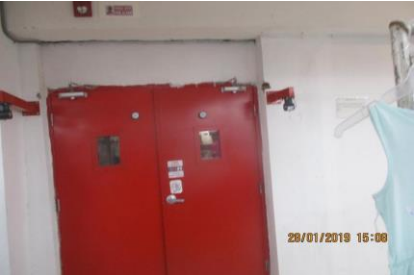
Item No	Accord Observation	Accord Recommendation	Timeline given by Accord	Comments after Physical Inspection	Supposed to complete(D D/MM/YYYY Y)	Final Action Plan (Factory)	Status on the date of Inspection	Pictorial Evidence
3	Rooms used for combustible storage on all floors are not separated by a minimum 1-hr fire-rated construction.	Provide dedicated storage rooms separated by minimum 1-hr fire-rated construction. Where separate storage rooms are not feasible, provide defined storage areas and limit the storage arrangement as follows: - Maximum height of 2.45m (8 ft) and maximum area of 23m <sup>2</sup> (250 ft <sup>2</sup> ) - If sprinkler protected: maximum height of 3.66m (12 ft) and maximum area of 93m <sup>2</sup> (1000 ft <sup>2</sup> ) Separate areas of unenclosed combustible storage by a minimum clear distance of 3m (10ft).	Within 3 months	On 24/05/2016: Partially corrected. Storage and store rooms are not separated by fire rated construction on 5th and 2nd floors. Factory management confirms that this issue will be completed within 30th May, 2016. On 19/07/2016: Partially corrected. Dedicated store room: Dedicated store room on 1st and ground floor is properly separated from other surroundings but store room on 4th floor is not properly separated beside canteen. In-process store: In-process store area found on 5th and 2nd floor which is not in proper store arrangement. Factory shall follow the recommended store arrangement. On 21/12/2016: In progress. Storage room in 4th floor has been found without any separation. The factory has maintained defined storage area limit on production floor. On 15/05/2017 : Corrected. dedicated storage has been provided and other storage are within limit of 250 sft, 8ft height and 10 ft. gap in working area. On 04/January/2018: Corrected On 24/07/2018: Corrected.  <b>On 28/01/2019: Corrected.</b>	'13/03/2016	corrected	Corrected

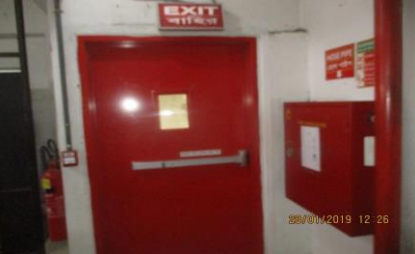
4	Egress doors and gates on the ground floor with locking features are provided at building exits.	Remove locking features from all egress doors and gates. If locks are required for security reasons, utilize special door locking features complying with ACCORD standard 6.8.2.	Immediately	On 24/05/2016: Corrected. Factory has removed non-compliant locking features from egress routes exit doors/gates. On 19/07/2016: Corrected. No such locking features were found during the time of 2nd follow-up inspection. On 21/12/2016: Corrected. Non-compliant locking feature has not been observed during follow-up inspection. On 15/05/2017 : Corrected. On 04/January/2018: Corrected On 24/07/2018: Corrected.  <b>On 28/01/2019: Corrected.</b>	'25/12/2015	done	Corrected

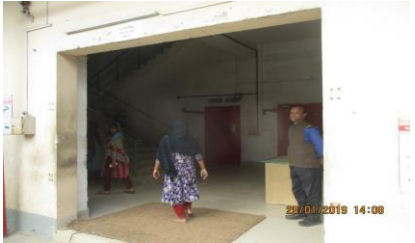
5	Collapsible gates and sliding doors on the ground floor are provided at building exits.	Replace all gates and sliding doors along the means of egress with side-hinged, swinging egress doors in accordance with ACCORD standard 6.8.1.	Within 1 month	On 24/05/2016: Corrected. Factory has removed non-compliant doors/gates from egress routes. On 19/07/2016: Corrected. No non-compliant gates were found during the follow-up inspection. On 21/12/2016: Corrected. Non-compliant gate has not been observed during follow-up inspection. On 15/05/2017 : Corrected. On 04/January/2018: Corrected On 24/07/2018: Corrected.  <b>On 28/01/2019: Corrected.</b>	'15/01/2016	corrected	Corrected

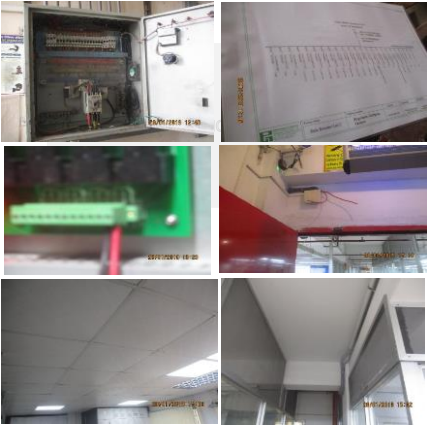
Item No	Accord Observation	Accord Recommendation	Timeline given by Accord	Comments after Physical Inspection	Supposed to complete(D/D/MM/YYYY)	Final Action Plan (Factory)	Status on the date of Inspection	Pictorial Evidence
7	Fire alarm system installation requires detailed review to confirm compliance with NFPA 72 and ACCORD standards.	Submit as-built drawings, testing records, equipment certification and other relevant documentation to the ACCORD for review and approval.	Within 1 month	<p>On 04/January/2018: Important observations after conducting the commissioning of the system:  1. Control panel was not protected due to hole at panel 2. Wiring entering and leaving control equipment is not protected from physical damage 3. Device Addresses are not clearly addressed for all initiating devices 4. Addresses on as built drawing does not match with site for some initiating devices 5. Proper Voltage drop calculations have not been provided 6. Correct size (as per provided calculation) batteries have not been provided for FACP 7. NAC shall be monitored or supervised by FACPv8. End of Line Resistors have not been installed at the end of the line 9. The PA system is not controlled by the fire alarm to turn off an alarm activation 10. Interfacing with fire pump has not been completed in proper way 11. Thermal sensor and thermal activity of multi sensor have not been tested</p> <p>On 24/07/2018: Factory reported that modification of the fire alarm system is almost done.</p> <p><b>On 28/01/2019: Refer to attached T&amp;C report.</b></p>	'30/08/2016	corrected Pending Verification	In Progress

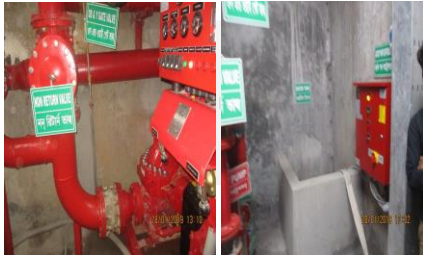
8	Fire pump installation requires detailed review to confirm compliance with NFPA 20 and ACCORD standards.	Submit as-built drawings, testing records, equipment certification and other relevant documentation to the ACCORD for review and approval.	Within 1 month	<p>On 04/January/2018: Important observations after commissioning of the installed system:  1. No water level gauge on the fire water reservoir as well as inadequate water reservoir has been provided (as per calculation and on site) 2. Fire pumps installation has not been completed as per NFPA 20 and fire pump does not perform to the pump rating 3. Required fuel is not possible to measure due to unknown size of the diesel tank as well as fuel level has been observed very low at fuel level gauge 4. Interfacing with fire alarm system has not been completed in proper way 5. The control valves in the fire pump room and the stand pipe system are not supervised 6. Proper pressure set up shall be confirmed of the system</p> <p>On 24/07/2018: Modification has been started.</p> <p><b>On 28/01/2019: Refer to attached T&amp;C report.</b></p>	'30/08/2016	corrected Pending Verification	In Progress

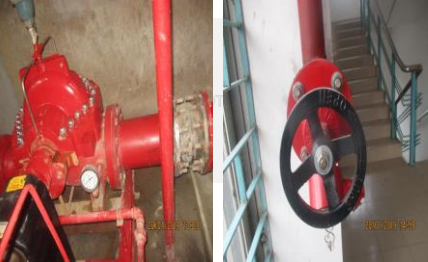
Item No	Accord Observation	Accord Recommendation	Timeline given by Accord	Comments after Physical Inspection	Supposed to complete(D D/MM/YYYY)	Final Action Plan (Factory)	Status on the date of Inspection	Pictorial Evidence
15	Standpipe system is required for the building, which has an occupiable floor 10 m (33 ft) or more above grade.	Install a new class III standpipe system in accordance with ACCORD standard 5.4 and NFPA 14. A class I system shall be permitted in buildings protected throughout by an approved automatic sprinkler system.	Within 6 months	On 04/January/2018: Important observations after commissioning of the installed system: 1. No water level gauge on the fire water reservoir as well as inadequate water reservoir has been provided (as per calculation and on site)c2. Fire pumps installation has not been completed as per NFPA 20 and fire pump does not perform to the pump rating 3. Required fuel is not possible to measure due to unknown size of the diesel tank as well as fuel level has been observed very low at fuel level gauge 4. Interfacing with fire alarm system has not been completed in proper way 5. The control valves in the fire pump room and the stand pipe system are not supervised 6. Proper pressure set up shall be confirmed of the system On 24/07/2018: Modification has been started. Third party certificate is required for landing valve.  <b>On 28/01/2019: Refer to attached T&amp;C report.</b>	'30/08/2016	corrected Pending Verification	In Progress

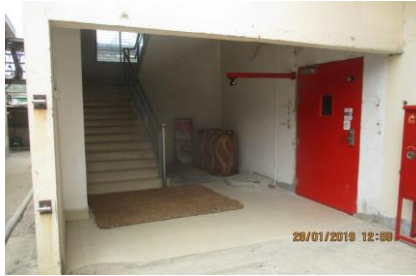
18	New Finding (24/05/2016): Electrical panel is located east-south and west-north exit stair enclosure on ground floor.	Relocate electrical panel from exit stair enclosure. OR, Separate the electrical panel by a minimum 2-hr fire-rated construction. Seal and/or protected all openings to maintain the required fire separations.	Within 3 months	On 24/05/2016: New Finding On 19/07/2016: Partially corrected. Electrical panel was removed from 1st exit stair enclosure but was found on stair-4. Besides combustible storages were found on stair-4 and stair-1 which they later removed and gave pictures. But storages were found in the egress path on ground floor at stair-2. Beside storages were found on the egress path on various floor beside exit and on the stair landing. Factory shall remove all the storages from the egress discharge path. On 21/12/2016: Corrected. Storage has not been observed in exit stair during follow-up inspection. On 15/05/2017 : Corrected. On 04/January/2018: Corrected On 24/07/2018: Corrected.  <b>On 28/01/2019: Corrected.</b>	'23/08/2016	corrected	Corrected

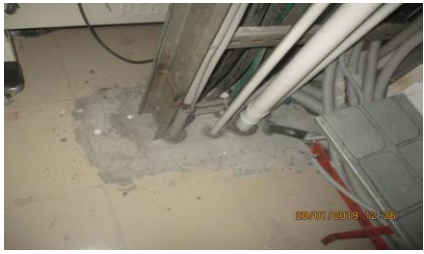
Item No	Accord Observation	Accord Recommendation	Timeline given by Accord	Comments after Physical Inspection	Supposed to complete(D D/MM/YYYY)	Final Action Plan (Factory)	Status on the date of Inspection	Pictorial Evidence
23	Penetrations through floor/ceiling assemblies were not sealed properly.	Seal all penetrations and openings in floor/ceiling (full thickness of the floor/ceiling) assemblies by fire rated materials to maintain the fire resistance rating. Provide a minimum 2-hr fire rated shaft to separate the utility risers from each floor if required.	Within 1 month	On 21/12/2016: New Finding On 15/05/2017 : It is found same as before. On 04/January/2018: Corrected On 24/07/2018: Corrected.  <b>On 28/01/2019:</b> Corrected as per previous follow-ups.	'21/01/2017	corrected	Corrected
