Structural Safety Inspection

Factory Name	Safaa Sweaters Ltd	Accord ID	12362
Factory Address	Begumpur, Bokran, Monipur, Bhawl Gore		
Inspection Date	18/10/2015		
Date of Review Inspection	1-Feb-18		
Inspected by	Md. Mucedul Islam

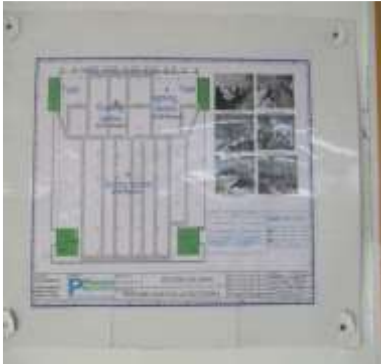
Item No	Accord Observation	Accord Recommendation	Accord Timeline	Final Action Plan	Final Timeline(DD/MM/YYYY)	Comments after Physical Inspection	Progress Status	Pictorial Evidence
3	Stress levels in Columns	Produce and actively manage a loading plan for all floor plates within the factory giving consideration to floor capacity and column capacity.	6-weeks	Corrected	26/06/2016	<p>On 19-July-2016: During inspection load was found under the design limit and load plan was posted on floor. Factory is required to maintain the load according to the load plan.</p> <p>On 15-May-2017: Corrected in the previous follow up inspection report. Load plan was prepared and submitted to ACCORD. Engineering assessment report along with with load plan was accepted by ACCORD. During inspection load plan was found posted in each floor and the load was within the limit as per accepted load plan</p> <p>On 01-Feb-2018: This issue was corrected from previous inspection. Load plan has been produced as part of EA report and accepted from ACCORD. During inspection, load was found as per accepted load plan.</p>	Corrected

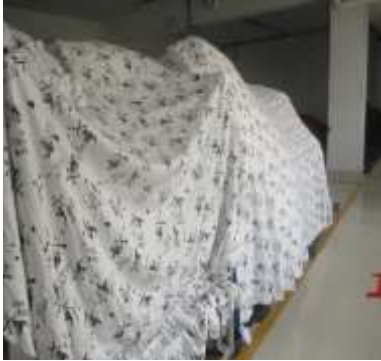
Item No	Accord Observation	Accord Recommendation	Accord Timeline	Final Action Plan	Final Timeline(DD/MM/YYYY)	Comments after Physical Inspection	Progress Status	Pictorial Evidence
5	Stress levels in Columns	Continue to implement load plan	6-months	Corrected	26/06/2016	<p>On 19-July-2016: During inspection load was found under the design limit and load plan was posted on floor. Factory is required to maintain the load according to the load plan.</p> <p>On 15-May-2017: Corrected in the previous follow up inspection report. Load plan was prepared and submitted to ACCORD. Engineering assessment report along with with load plan was accepted by ACCORD. During inspection load plan was found posted in each floor and the load was within the limit as per accepted load plan</p> <p>On 01-Feb-2018: This issue was corrected from previous inspection. Load plan has been produced as part of EA report and accepted from ACCORD. During inspection, load was found as per accepted load plan.</p>	Corrected

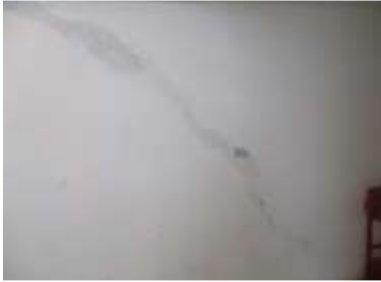
Item No	Accord Observation	Accord Recommendation	Accord Timeline	Final Action Plan	Final Timeline(DD/MM/YYYY)	Comments after Physical Inspection	Progress Status	Pictorial Evidence
8	Cracking in masonry in cantilever portions of the building	Make any structural alterations as advised by Engineer.	6-months	Corrected	26/06/2016	<p>On 19-July-2016: During inspection, repairing work was found on masonry crack at cantilever portion. Factory should maintain the load according to load plan and required a regular monitoring weather it comes back or not.</p> <p>On 15-May-2017: Corrected in the previous follow up. Factory engineer has declared in DEA report, this cracks was non structural.</p> <p>On 01-Feb-2018: This issue was corrected from previous inspection. As per EA report, cracks in masonry wall were non-structural. Factory need to maintain a periodic follow up on this cracks.</p>	Corrected

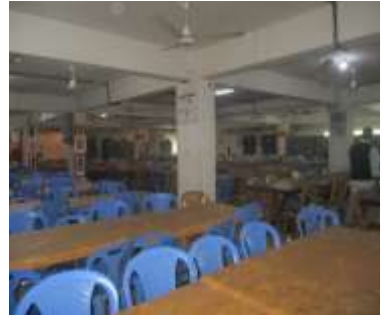
9	Cracking in masonry in cantilever portions of the building	Continue to implement load plan	6-months	Corrected	26/06/2016	<p>On 19-July-2016: Factory did the review design as part of DEA and got approval from ACCORD in 26-June-2016. During inspection, floor use was found according to the approved plan and load was found less than the load plan.</p> <p>On 15-May-2017: Corrected in the previous follow up. Factory engineer has declared in DEA report, this cracks was non structural.</p> <p>On 01-Feb-2018: This issue was corrected from previous inspection. As per EA report, cracks in masonry wall were non-structural. Factory need to maintain a periodic follow up on this cracks. During inspection, load was found as per accepted load plan.</p>	Corrected

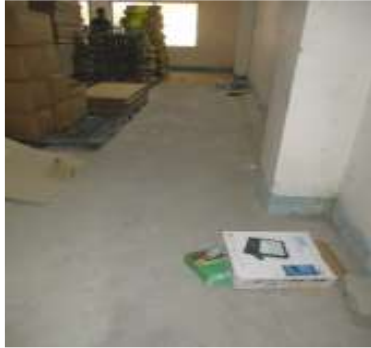
Item No	Accord Observation	Accord Recommendation	Accord Timeline	Final Action Plan	Final Timeline(DD/MM/YYYY)	Comments after Physical Inspection	Progress Status	Pictorial Evidence
11	Cracking on floor surface	Carry out any remedial work as directed by the Factory Engineer.	6-months	Corrected	26/06/2016	<p>On 19-July-2016: As part of DEA, factory investigate the crack and found the crack was on only floor finish. Factory is required repair the crack according to the recommendation of DEA.</p> <p>On 15-May-2017: Corrected in previous follow up. Factory engineer has declared that, this cracks was non structural. Repairing works on 1st floor level was on going.</p> <p>On 01-Feb-2018: This issue was corrected from previous inspection. As per EA report, cracks in floor slab were non-structural. Repairing work was found completed. Factory need to maintain a periodic follow up on this cracks. During inspection, load was found as per accepted load plan.</p>	Corrected
