FIRE SAFETY FOLLOW UP INSPECTION

Factory Name	Ayesha Clothing Co. Ltd.		Accord ID	9713
Address	Jamgara, Gazirchot Alia Madrasha, Ashulia			
Inspection Date	03/05/2014	Report Received Date		
Date of 1st Follow-up	09/11/2015	Date of 2nd Follow-up	10/03/2016	
Date of 3rd Follow-up	11/04/2017	Date of 4th Follow-up	23/07/2017	
Date of 5th Follow-up	30/07/2018	Date of 6th Follow-up	18/11/2018	
Date of 7th Follow-up		Date of 8th Follow-up		
Date of 9th Follow-up		Date of 10th Follow-up		
Date of 11th Follow-up		Date of 12th Follow-up		
Date of 13th Follow-up		Date of 14th Follow-up		
Inspected by	Noshin Tabassum

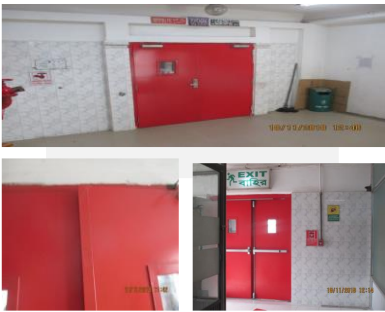
Item No	Accord Observation	Accord Recommendation	Timeline given by Accord	Comments after Physical Inspection	Supposed to complete(DD/MM/YYYY)	Final Action Plan (Factory)	Status on the date of Inspection	Pictorial Evidence
9	Door widths are more than 0.8m. Visually, some of the doors appear to be fire doors. However, no credible certificate is available. Fire doors of proper rating are required in accordance with section 6.3.1.2.2 and 4.6. There are non-rated doors present at each floor of the main building.	Provide 1 hr fire protective opening assemblies in 1 hr rated exit enclosure. Provide 1.5 hr fire protective opening assemblies in 2 hr rated exit enclosure. Exits connecting three or fewer stories shall be enclosed with a minimum 1-hr fire resistance rating. Exits connecting four or more stories shall be enclosed with a minimum 2-hr fire-resistance rating. Exits shall be enclosed with the same fire-resistance rating as the floor penetrated but will not need to exceed 2 hr. Provide fire door of required rating to access the corridor.	9/4/2014 12:00:00 AM	On 10/03/16: Partially corrected. Civil construction and fire door installation is completed. Interfacing with fire alarm is going on. On 11/04/17: Partially corrected. Civil construction and fire door installation is completed. Interfacing with fire alarm is going on. On 23/07/2017: Factory has installed fire doors but doors were found open through some external sources. Besides doors were not closing properly as door coordinators were not fully functional. On 30/07/2018: Factory has installed fire doors but doors were found open through some external sources. Besides, door accessories were not functional in proper way & found out of order. On 18-11-2018: In progress. Fire door has been installed but door accessories were not functional in few places. Factory has informed that magnetic door holder are in house and installation will be started very soon. However the bottom gap of fire doors shall be as per standard.	*13/04/2016	Corrected We are keeping all the fire door closed.	In Progress

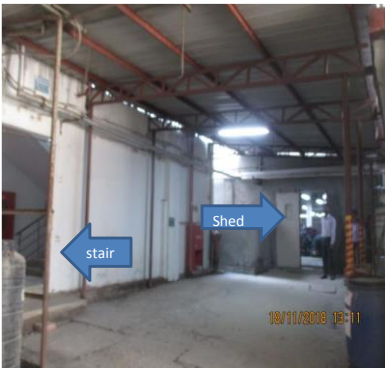
10	There are eight exit stairways available at the main building. Only one of these exit stairways discharges directly to the exterior of the building.	Provide rated exit passageway (protected path of egress) from the exit enclosure to the public way. The rating of the exit passageway is to be equal to fire rating requirement of the exit that is being served and shall not be less than 1 hr fire-resistance rated.	9/4/2014 12:00:00 AM	On 10/03/16: Partially corrected. Civil construction and fire door installation is completed. Interfacing with fire alarm is going on. Final CAP Timeline: Expired. Committed Timeline: Within 13 April, 2016. On 11/04/17: Partially corrected. Civil construction and fire door installation is completed. Interfacing with fire alarm is going on. On 23/07/2017: Factory has installed fire doors but doors were found open through some external sources. Besides doors were not closing properly as door coordinators were not fully functional. On 30/07/2018: Factory has installed fire doors but doors were found open through some external sources. Besides, door accessories were not functional in proper way & found out of order. On 18-11-2018: Not corrected yet.	*13/04/2016	Corrected We are keeping all the fire door closed.	In Progress

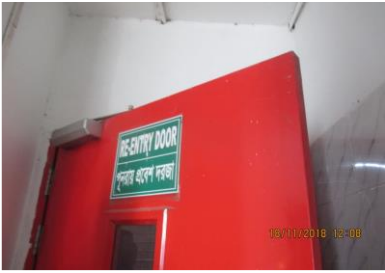
Item No	Accord Observation	Accord Recommendation	Timeline given by Accord	Comments after Physical Inspection	Supposed to complete(DD /MM/YYYY)	Final Action Plan (Factory)	Status on the date of Inspection	Pictorial Evidence
19	The main building is an 8 story building. Two re-entry doors are necessary on the 2nd floor and 7th floor, but re-entry doors are not available.	Every door in a stair enclosure serving more than 5 stories shall be provided with re-entry unless it meets the following requirements. Stairwell doors may be permitted to be locked from the stair (ingress) side that prevents re-entry to the floor provided at least two floors allowing re-entry to access another exit are provided, there are not more than 4 stories intervening between re-entry floors, re-entry is allowed on the top or next to top level, reentry doors are identified as such on the stair side, and locked doors shall be identified as to the nearest re-entry floors. When the discharge floor is determined to be a required re-entry floor using the above requirements, re-entry does not have to be provided back into the building on this level.	9/4/2014 12:00:00 AM	On 10/03/16: Corrected. On 11/04/17: Corrected. On 23/07/2017: Corrected. On 30/07/2018: Corrected. On 18-11-2018: Corrected	'13/03/2016	Corrected	Corrected

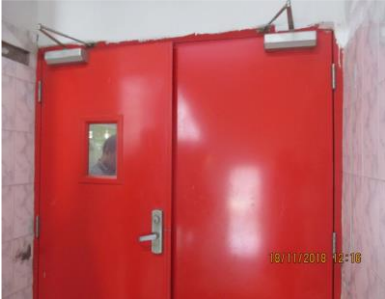
21	The utility prefabricated shed generator and gas cylinder room are not separated properly. Mobile generator directly opens to the walking space in front of the main building and utility building without fire separation. Flammable materials(1500 liter diesel) directly open to the main building corridors without separation. The main building chemical store is very close to the production area and finished goods without fire rated construction barriers.	Provide fire-resistive rated construction barriers between hazard types following Table 4.4.1 of Alliance Standard or Table 4.1.1 from BNBC Part 4. Consult a qualified fire protection engineer to design the required rated construction barrier.	11/27/2014 12:00:00 AM	On 10/03/16: Partially corrected. Diesel store, gas cylinder and mobile generator has been removed. At chemical store, civil construction and fire door installation is completed. Interfacing with fire alarm is going on. On 11/04/17: Partially Corrected. Diesel store, gas cylinder and mobile generator has been removed. Interfacing with fire alarm is going on. On 23/07/2017: Civil work and fire rated door installation work is in progress. On 30/07/2018: Interfacing of fire door has not been completed yet. Chemical storage area shall be separated properly by fire rated construction. On 18-11-2018: Partially corrected. Fire rated separation has been provided in chemical room. Fire door has been installed for finish goods store but few doors were not working properly and the bottom gap of fire doors shall be as per standard.	'13/04/2016	In progress we are keeping all fire door closed. But interfacing work is going on and will be completed by 30th November 2018	In Progress

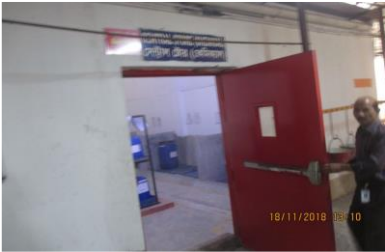
22	1. Exit of childcare is in front of the store room and childcare corridor is not properly fire rated. 2. Flammable materials are not stored as per MSDS (Material Safety Data Sheet). 3. Assembly point is not marked properly. 4. Main building is adjacent to market place without fire separation.	(1) Close the door of childcare to the store. Provide proper fire rating in the walls and ceiling of childcare. (2) Store the flammable material as per MSDS. (3) Provide proper marking of assembly point. (4) Provide proper fire rating between the wall of main building and adjacent marketplace.	8/31/2014 12:00:00 AM	On 10/03/16: Partially corrected. Day care room has been shifted, civil construction and fire door installation is completed at flammable material store and civil construction is completed between the wall of main building and adjacent market place. On 11/04/17: Interfacing is needed. On 23/07/2017: Installed fire doors at chemical room on ground floor are not interfaced yet and were found open through some external sources. On 30/07/2018: Interfacing of fire door has not been completed yet. Chemical storage area shall be separated properly by fire rated construction. On 18-11-2018: Corrected. Fire door has been installed in chemical room. Note: Factory shall install magnetic door holder if they keep the door open.	'13/04/2016	In progress we are keeping all fire door closed. But interfacing work is going on and will be completed by 30th November 2018	Corrected

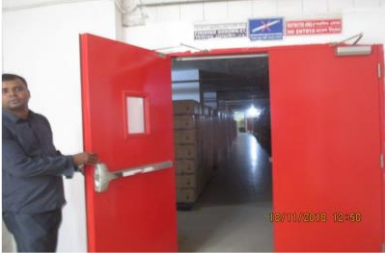
49	New Finding: Room used for combustible storage are not separated by Fire- rated construction.	Provide dedicated storage rooms separated by minimum 1- hr fire-rated construction. Where separate storage rooms are not feasible. Provide defined storage areas and limit the storage arrangement as follows: - Maximum height of 2.4m and maximum area of 23m2. - If sprinkler protected: maximum height of 3.66m2. Separate areas of unenclosed combustible storage by a minimum clear distance of 3m.	Within 3 months	On 10/03/16: Work in progress. Factory needs to provide proper fire separation at all rooms used for combustible storage. On 11/04/17: Work in progress. Factory needs to provide proper fire separation at all rooms used for combustible storage. On 23/07/2017: Dedicated store room was found on 1st and 5th floor without any separation with finishing section. Store room was found on ground floor where fire doors were found open through some external sources. On 30/07/2018: It was found same as before. On 18-11-2018: Fire door has been installed but door coordinators were not functional in few places. Magnetic door holder were in house but installation has not been started yet. The bottom gap of fire doors shall be as per standard.	'13/04/2016	Corrected We are keeping all the fire door closed.	In Progress
