Structural Safety Inspection

Factory Name & Address		Ayesha Clothing Co. Ltd., Jangara, Gazirchot Alia Madrasha, Ashulia, Dhaka, Dhaka
Inspection Date		4-May-14
Date of Review Inspection		9-Nov-15
Inspected by		Md. Abdul Malek

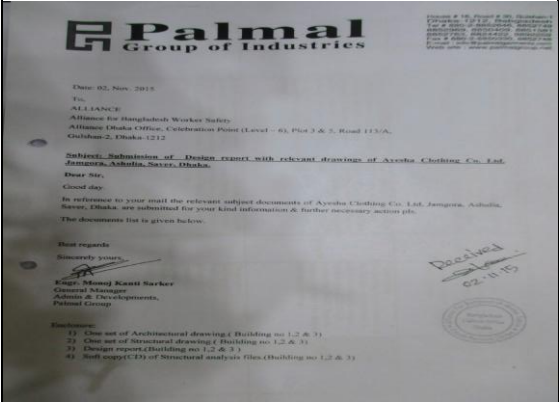
Item No	Accord Observation	Accord Recommendation	Final Action Plan	Final Timeline	Comments after Physical Inspection	Status on the date of Inspection	Pictorial Evidence
2	The structural members constructed with MCAC have not been investigated by an appropriate program of in-situ testing and representative destructive testing or core samples. However, for building 2 which is made of stone chips, the column stress calculated taking into account the strength of concrete from the standard, shows over-stressing.	Conduct detailed structural assessment by qualified structural engineer and carry out remedial action as necessary.	*Completed. *DEA is not required for building no 2 basing on item no. 1	30/04/2015	DEA has been done & submitted to Alliance for review.	In Progress

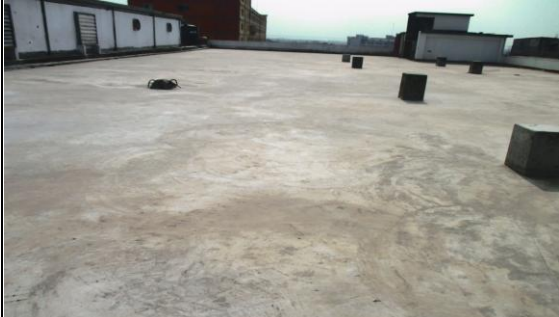
3	Dampness has been found at some floor of these three buildings. Standing water also been found on the roof top of the building 2 and 3.	Under guidance from a qualified structural engineer, address all areas of needed maintenance by correcting the identified issues.	*In progress. * Dampness of all these three buildings were removed by repairing under supervision of our own civil engineering team. * Provision of proper sloping on roof top of building 2 and 3 have been under taken and work is in progress.	13/06/2015	Since it is now non-rainy season, no dampness has been found during inspection period. There are 4 building in the factory premises. Slope has been done for building 2 only. Factory management are advised to apply water proofing materials or make slope for all buildings.	In Progress

4	The roof of the building is of MCAC aggregate, but no protective sealing is available.	Provide a protective coating at the structural elements constructed with MCAC exposed to rainfall or other sources of water. Have protective coating approved by the Alliance or a qualified structural engineer. Alternatively provide 2% slope on the exposed surface to prevent accumulation of water.	*In progress. * The works for remediation of water ponding at building no. 2 and 3 is in progress. At building no. 1, no water ponding occurs, having adequate slope on roof surface to drain out rain water with down pipes.	17/06/2015	There are 4 building in the factory premises. Slope has been done for building 2 only. Factory management are advised to apply water proofing materials or make slope for all buildings.	In Progress

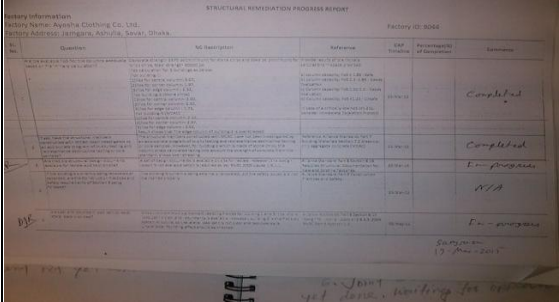
Item No	Accord Observation	Accord Recommendation	Final Action Plan	Final Timeline	Comments after Physical Inspection	Status on the date of Inspection	Pictorial Evidence
5	The building is currently being externally renovated, but the safety issues are not maintained properly.	Immediate safety issues should be applied. The management should ensure that the construction and safety practices are being adhered to as per BNBC 2006 and as per section 9 of Alliance Standard.	* Completed * The Alliance Team during their 1st Remediation Verification Visit on 13/05/2015 at ACCL declared the issue at Item no 5 as "Not Applicable"	30/04/2015	This item is N/A now as per Alliance.	Corrected

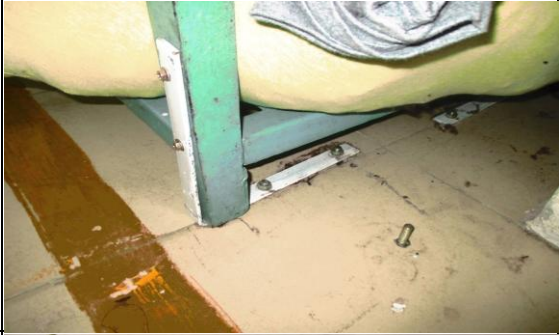
Item No	Accord Observation	Accord Recommendation	Final Action Plan	Final Timeline	Comments after Physical Inspection	Status on the date of Inspection	Pictorial Evidence
12	All non-structural elements were found non-braced. Some plastic tanks resting on the roof top and also some racks in different floors are not adequately anchored or braced to resist earthquake forces.	Adequately anchor and brace all non-structural elements to resist earthquake forces to comply with the BNBC and Alliance Standard	* In progress. * The works of anchoring and bracing is going on under supervision of our own civil engineering team and factory management.	17/06/2015	Anchoring has been done.	Corrected

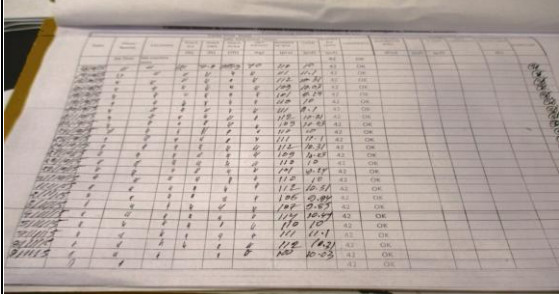
13	There is no program that will ensure that the designated load in each floor will not be exceeded	Develop a program to ensure that all live loads for which a floor or roof has been designed for will not be exceeded. The designated Load Manager shall oversee this program and ensure it is enforced.	Completed	30/04/2015	Not yet done properly. Factory management have shown a program that was not proper.	In Progress

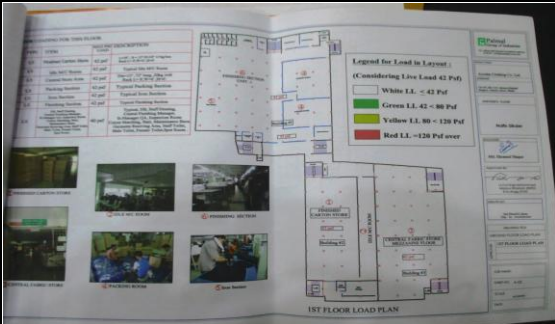
15	Floor Load Plans are available, but not as per standard.	Have a qualified structural engineer develop Floor Loading Plans per the requirements of Part 8 Section 8.20.5.3	* In progress and is related with submission of design report to be prepared by building engineers.	13/06/2015	Load plan has been prepared as part of DEA. Load plan were shown during inspection period & submitted to Alliance for review.	In Progress

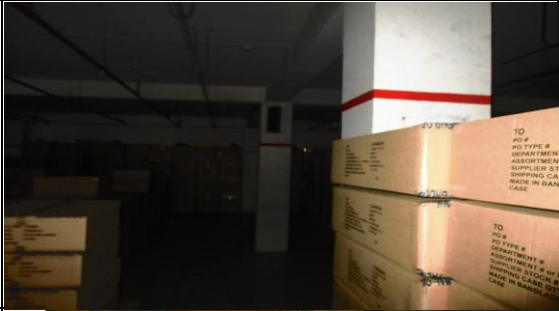
Item No	Accord Observation	Accord Recommendation	Final Action Plan	Final Timeline	Comments after Physical Inspection	Status on the date of Inspection	Pictorial Evidence
16	Floor Load Plans are not posted as required.	To have a qualified structural engineer prepare load plans including the information required in Section 8.205.3 of the Alliance Standard & also posting in each panel of all floors.	Completed	30/04/2015	Load plan has been prepared as part of DEA. Load plan were shown during inspection period & submitted to Alliance for review.	In Progress	
17	Storage of work materials and work products are not marked to indicate the acceptable loading limit as well as Floor loads plan is not available in the floor.	Have a qualified structural engineer prepare a load plan for each floor and have the floors marked for designating storage area as per the developed load plan.	* In progress. * Storage at floors will be marked and will be in corporate in floor load plans as suggested by ALLIANCE team during 1st Remediation Verification Visit on 13/05/2015 at ACCL.	13/06/2015	Temporary markings have been done as their load plan is under review in Alliance.	In Progress

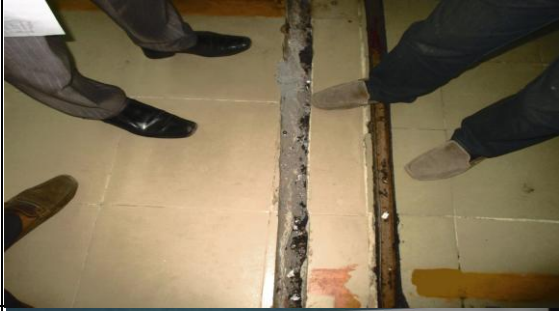
18	An expansion joint has been provided in between building 2 & 3 in the exterior facade; this expansion joint is blocked.	Joint between building-2 and 3 must be free from blockage.	* In progress. * Expansion joint will be made free as suggested by the ALLIANCE team during the 1st remediation verification visit on 13/05/2015 at ACCL.	13/07/2015	Not yet done.	In Progress
