FIRE SAFETY FOLLOW UP INSPECTION

Factory Name	Safaa Sweaters Ltd		Accord ID	12362
Address	Begumpur, Bokran, Monipur, Bhawl Gore			
Initial Inspection Date	14-Oct-2015	Report Received Date		
Date of 1st Follow-up	24-May-2016	Date of 2nd Follow-up	19-Jul-2016	
Date of 3rd Follow-up	21-Dec-2016	Date of 4th Follow-up	15-May-2017	
Date of 5th Follow-up	04-Jan-2018	Date of 6th Follow-up	24-Jul-2018	
Date of 7th Follow-up	28-Jan-2019	Date of 8th Follow-up	20-Nov-2019	
Date of 9th Follow-up		Date of 10th Follow-up		
Date of 11th Follow-up		Date of 12th Follow-up		
Date of 13th Follow-up		Date of 14th Follow-up		
Inspected by	Md. Rafat Arefin

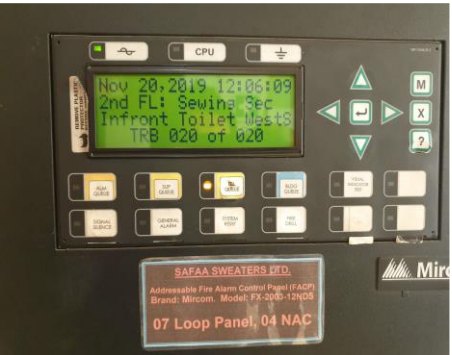
Item No	Accord Observation	Accord Recommendation	Timeline given by Accord	Comments after Physical Inspection	Supposed to complete(DD/MM/YYYY)	Final Action Plan (Factory)	Status on the date of Inspection	Pictorial Evidence
7	Fire alarm system installation requires detailed review to confirm compliance with NFPA 72 and ACCORD standards.	Submit as-built drawings, testing records, equipment certification and other relevant documentation to the ACCORD for review and approval.	Within 1 month	<p>On 04/January/2018: Important observations after conducting the commissioning of the system: 1. Control panel was not protected due to hole at panel 2. Wiring entering and leaving control equipment is not protected from physical damage 3. Device Addresses are not clearly addressed for all initiating devices 4. Addresses on as built drawing does not match with site for some initiating devices 5. Proper Voltage drop calculations have not been provided 6. Correct size (as per provided calculation) batteries have not been provided for FACP 7. NAC shall be monitored or supervised by FACPv8. End of Line Resistors have not been installed at the end of the line 9. The PA system is not controlled by the fire alarm to turn off an alarm activation 10. Interfacing with fire pump has not been completed in proper way 11. Thermal sensor and thermal activity of multi sensor have not been tested</p> <p>On 24/07/2018: Factory reported that modification of the fire alarm system is almost done. On 28/01/2019: Refer to attached T&C report.</p> <p>On 20-12-2019: Factory shall modify the system in compliance with NFPA-72 and ask for T&Cx inspection.</p>	30-Aug-2016	Installation completed at some new area commissioning pending, all pending issue will be completed by 31st August 2019.	In Progress

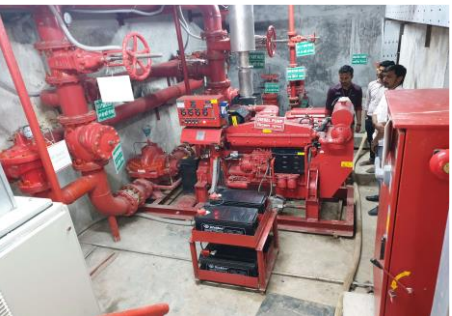
8	Fire pump installation requires detailed review to confirm compliance with NFPA 20 and ACCORD standards.	Submit as-built drawings, testing records, equipment certification and other relevant documentation to the ACCORD for review and approval.	Within 1 month	<p>On 04/January/2018: Important observations after commissioning of the installed system: 1. No water level gauge on the fire water reservoir as well as inadequate water reservoir has been provided (as per calculation and on site) 2. Fire pumps installation has not been completed as per NFPA 20 and fire pump does not perform to the pump rating 3. Required fuel is not possible to measure due to unknown size of the diesel tank as well as fuel level has been observed very low at fuel level gauge 4. Interfacing with fire alarm system has not been completed in proper way 5. The control valves in the fire pump room and the stand pipe system are not supervised 6. Proper pressure set up shall be confirmed of the system</p> <p>On 24/07/2018: Modification has been started. On 28/01/2019: Refer to attached T&C report.</p> <p>On 20-12-2019: Factory shall modify the system in compliance with NFPA-20,14 and ask for T&Cx inspection.</p>	30-Aug-2016	Corrected Pending varification	In Progress

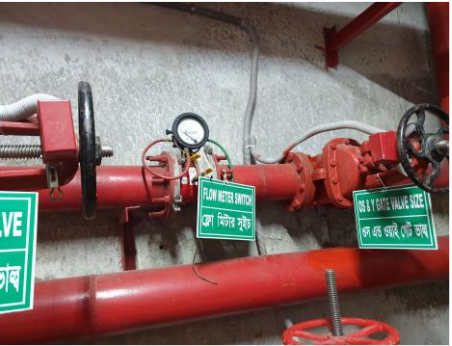
Item No	Accord Observation	Accord Recommendation	Timeline given by Accord	Comments after Physical Inspection	Supposed to complete(DD/MM/YYYY)	Final Action Plan (Factory)	Status on the date of Inspection	Pictorial Evidence
15	Standpipe system is required for the building, which has an occupiable floor 10 m (33 ft) or more above grade.	Install a new class III standpipe system in accordance with ACCORD standard 5.4 and NFPA 14. A class I system shall be permitted in buildings protected throughout by an approved automatic sprinkler system.	Within 6 months	<p>On 04/January/2018: Important observations after commissioning of the installed system: 1. No water level gauge on the fire water reservoir as well as inadequate water reservoir has been provided (as per calculation and on site)c2. Fire pumps installation has not been completed as per NFPA 20 and fire pump does not perform to the pump rating 3. Required fuel is not possible to measure due to unknown size of the diesel tank as well as fuel level has been observed very low at fuel level gauge 4. Interfacing with fire alarm system has not been completed in proper way 5. The control valves in the fire pump room and the stand pipe system are not supervised 6. Proper pressure set up shall be confirmed of the system On 24/07/2018: Modification has been started. Third party certificate is required for landing valve. On 28/01/2019: Refer to attached T&C report.</p> <p>On 20-12-2019: Factory shall modify the system in compliance with NFPA-20,14 and ask for T&C inspection.</p>	30-Aug-2016	Corrected Pending varification	In Progress

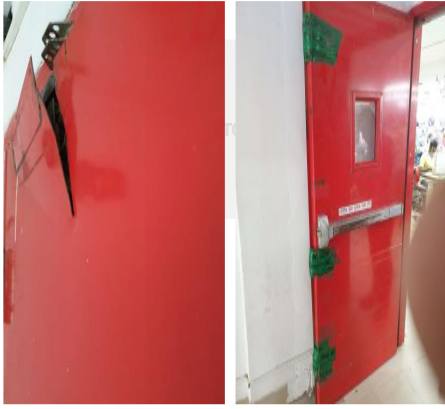
22	New Finding (3rd Follow Up): During follow-up inspection it has been observed that the exit stairs are not properly separated from [work areas, other spaces] on each floor by fire rated construction due to improper fire door accessories (malfunction of door co-ordinator, missing vision panel and door closer).	Seal all unprotected openings to separate the exit stairs from work areas and other building spaces on all floor levels. Ensure the proper installation of fire door accessories and the fire doors are self-closing and positive latching. If fire doors are required to be held open for functional reasons, provide automatic-closing devices tied to the fire alarm system.	Within 1 month	On 21/12/2016: New Finding, On 15/05/2017 : It is found same as before. On 04/January/2018: Numerous number of installed fire doors were found damaged. Factory shall provide Magnetic hold open device at all the installed fire doors. Factory management keep the fire doors open with the help of manual support. During the Testing & commissioning of the installed Fire Alarm & Detection System, fire doors those were kept open with the help of external support did not close. Installed fire doors at store rooms on 1st floor was held open manually during the commissioning of the installed Fire Alarm & Detection system. Another observation regarding the exit discharge point : Stair-04 at exit discharge point on ground floor has unprotected window opening from the store room. On 24/07/2018: Installed fire doors are required proper functional with necessary equipment. If fire doors are required to be held open for functional reasons, provide automatic-closing devices tied to the fire alarm system. On 28/01/2019: No significant progress since last FUI regarding this issue. On 20-11-2019: In progress. Installed Fire doors were found damaged.	21-Jan-2017	Corrected Pending varification	In Progress
